LOCAL HISTORIC DISTRICT: Dilworth

PROPERTY ADDRESS: 708 Mt. Vernon Avenue

SUMMARY OF REQUEST: Addition/Renovation/Window removal

Details of Proposed Project: 708 Mt. Vernon Avenue

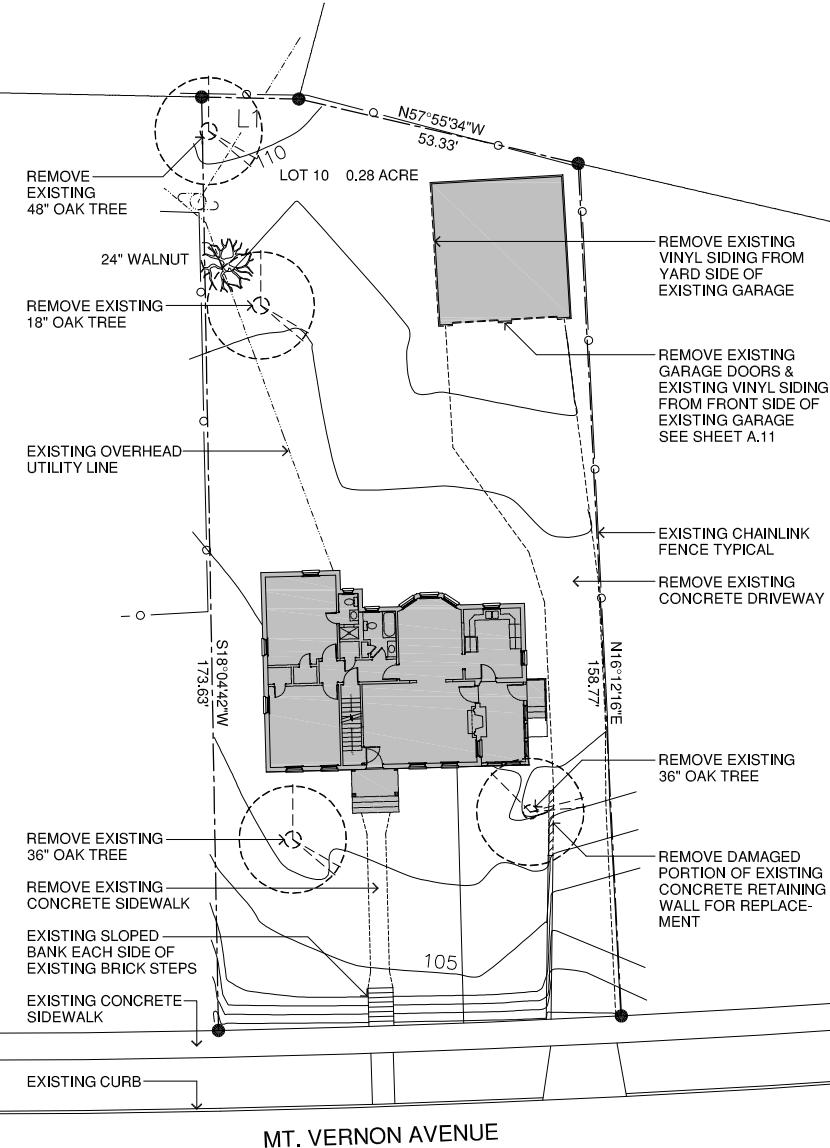
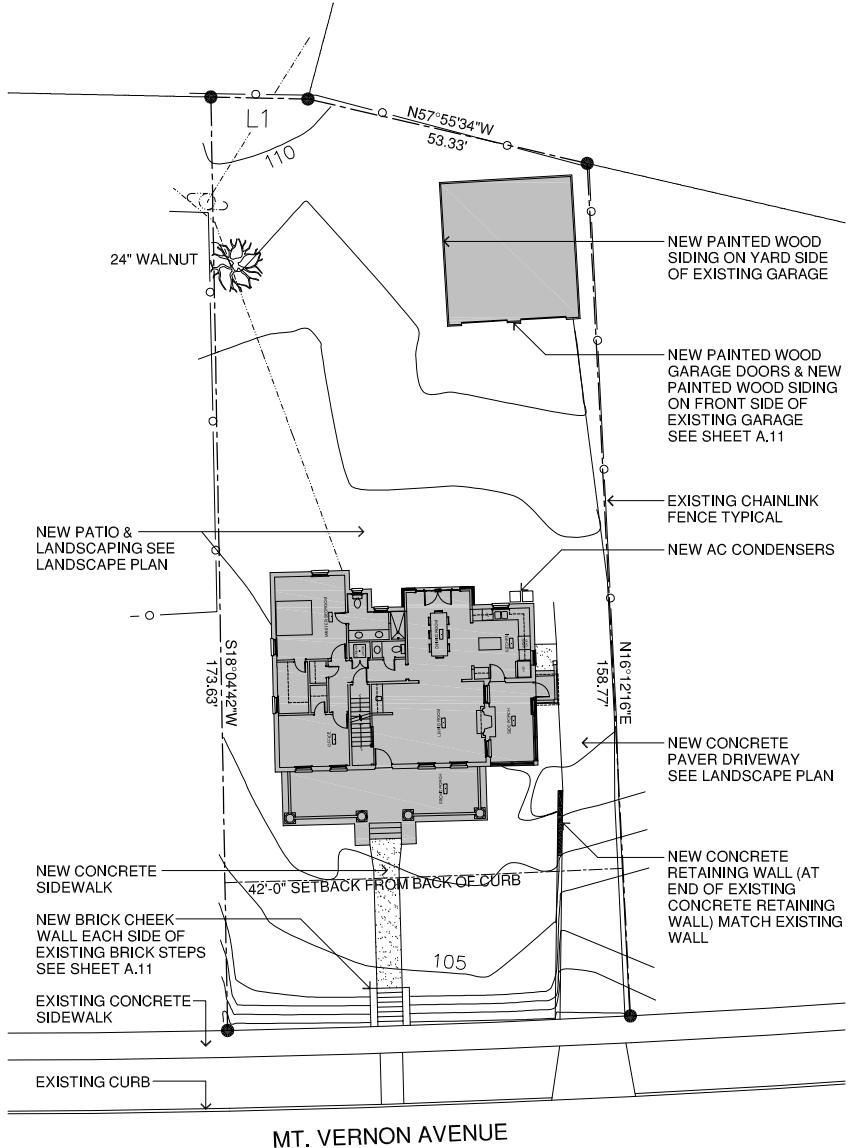
A.4

SITE PLAN
EXISTING and
PROPOSED

- The site measures 12,108 square feet (approximately .28 acres).
- The foot print of the existing house including all extremities measures 1703 sq. ft and comprises approximately 14 % of the site.
- The proposed footprint of the existing house plus proposed additions (new front porch and dining room extension to the rear) comprises 17% of the site.
- The new addition raises the footprint to site ratio by 3%.

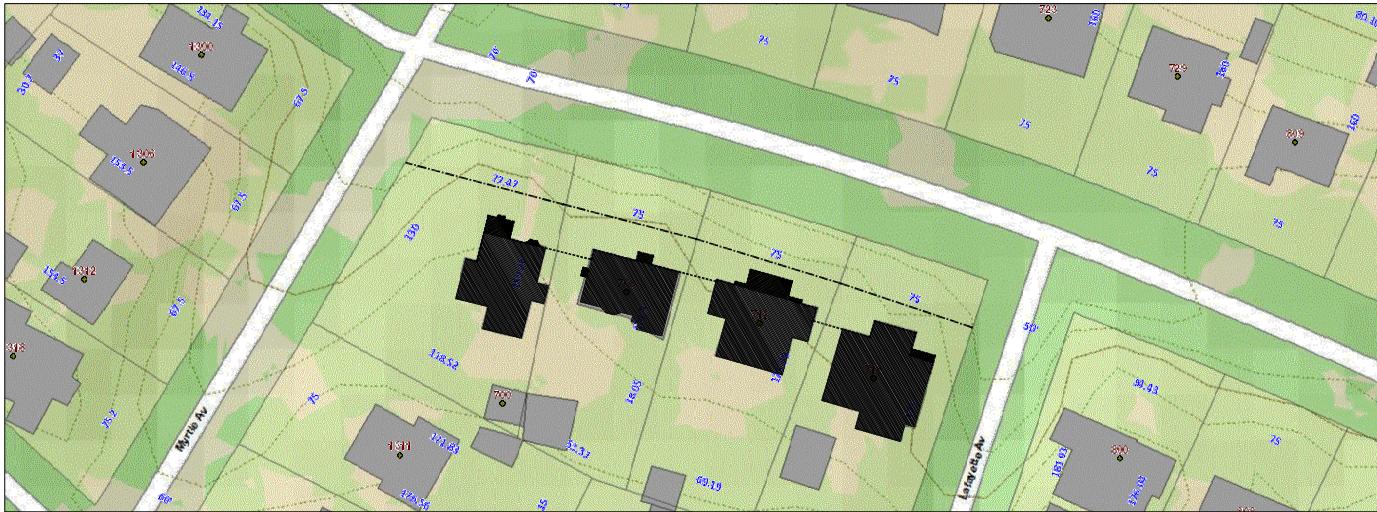
A EXISTING FRONT YARD SETBACK

SCALE: 1/32" - 1'-0"

----- ZONING SETBACK (42'-0" FROM BACK OF CURB)
..... ESTABLISHED SETBACK (ALONG FRONTS OF HOUSES)

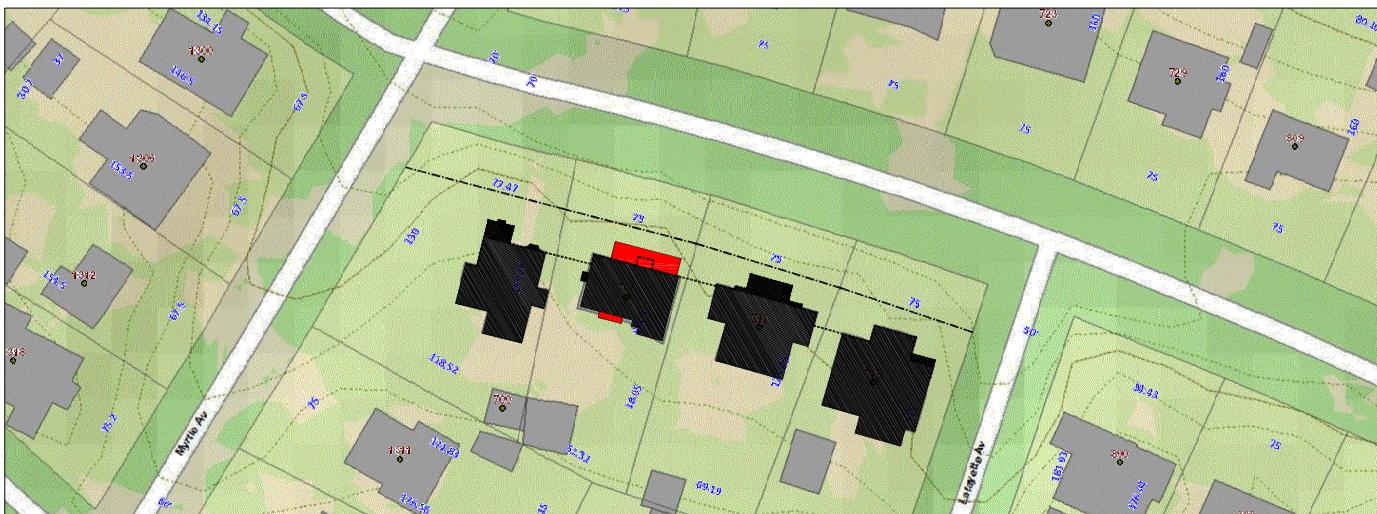
B PROPOSED FRONT YARD SETBACK

SCALE: 1/32" - 1'-0"

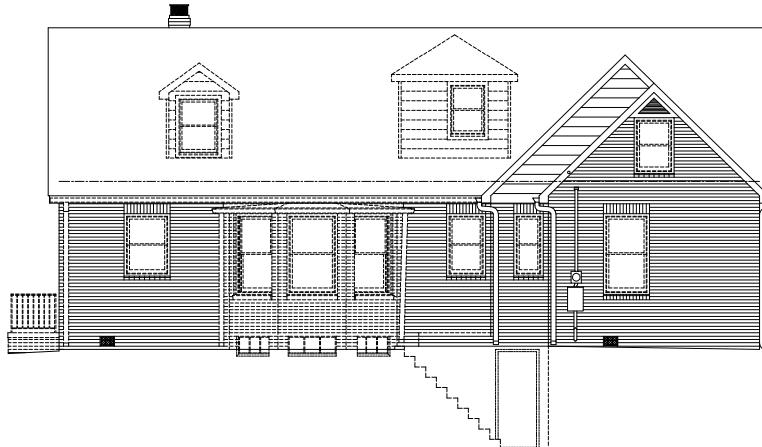
A EXISTING / DEMO REAR ELEVATION

SCALE: 1/4" = 1'-0"

- Removal of existing brick bay window and extension of dining room. This work will not be higher or wider than the original house and will not be visible from the street.
- Window Replacement

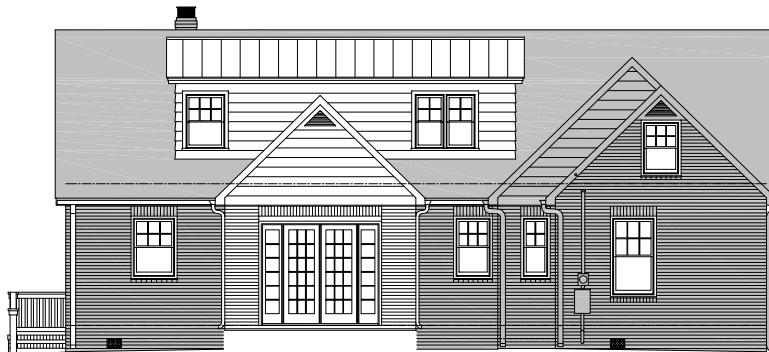
B PROPOSED REAR ELEVATION

SCALE: 1/4" = 1'-0"

- All window sizes and locations remain original except for the bay window on the rear elevation that is to be removed and replaced with new patio doors and windows.
- One existing window (located on the right elevation) is to be removed and its opening in-filled with a unique brick pattern to differentiate the new from the existing and articulate right elevation.
- All new windows and doors are painted wood semi-divided lite with painted wood trim.

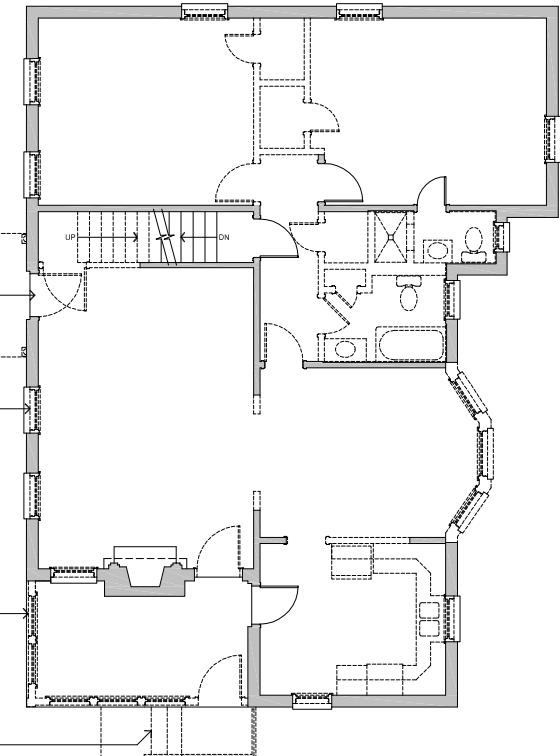
A FIRST FLOOR EXISTING / DEMO PLAN

REMOVE EXISTING
PORCH (INCLUDING
WROUGHT IRON
RAILINGS, WOOD
ROOF & COLUMNS,
CONCRETE FLOOR
W/QUARRY TILE,
MASONRY FOUNDATION
WALLS & STEPS
(DASHED LINES))

REMOVE EXISTING
PORCH WALLS,
WINDOWS & DOOR
(DASHED LINES)

REMOVE EXISTING
STOOP, STEPS &
RAILING (DASHED
LINES)

SCALE: 1/4" = 1'-0"

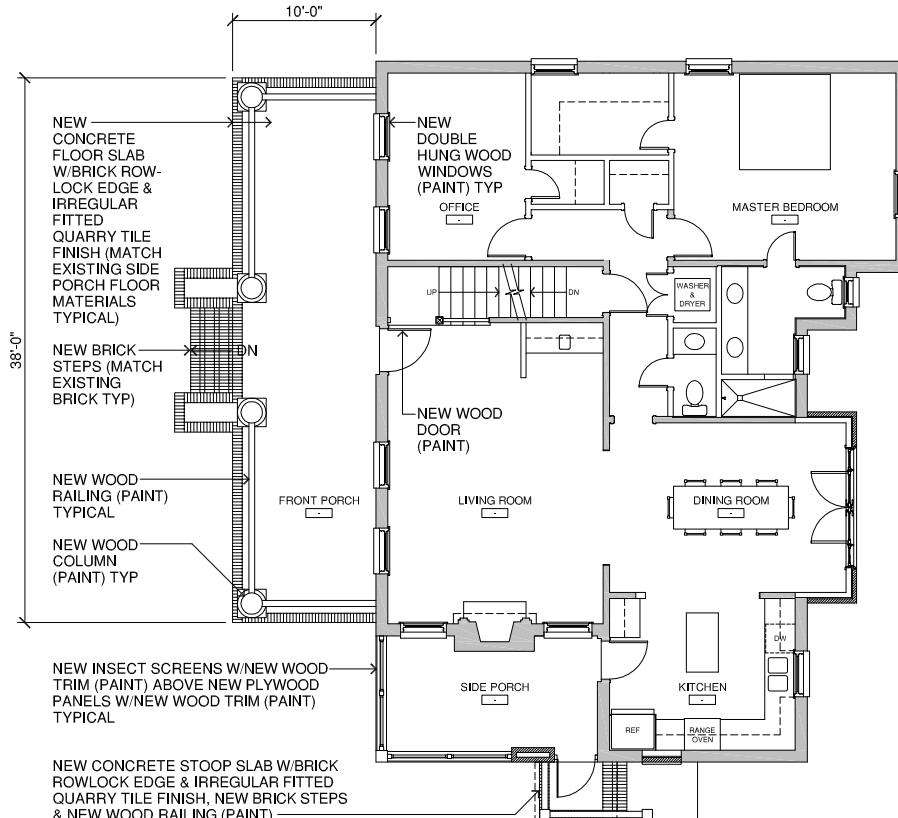
B FIRST FLOOR PROPOSED PLAN

SCALE: 1/4" = 1'-0"

The proposal for Commission review is the addition of a front porch, overhang on right side, window removal/infill and conversion of the side addition to a screened porch. The porch addition dimension is 38' x 10'. Features include new brick steps, concrete floor, wood columns, wood hand rails and standing seam metal roof.

The right side porch plan includes the removal of two windows and walls to be replaced with screens and plywood panels below. The overhang will have a matching metal roof and brackets. The window infill will be replaced with brick in a contrasting pattern. New hand rails will match the front porch.

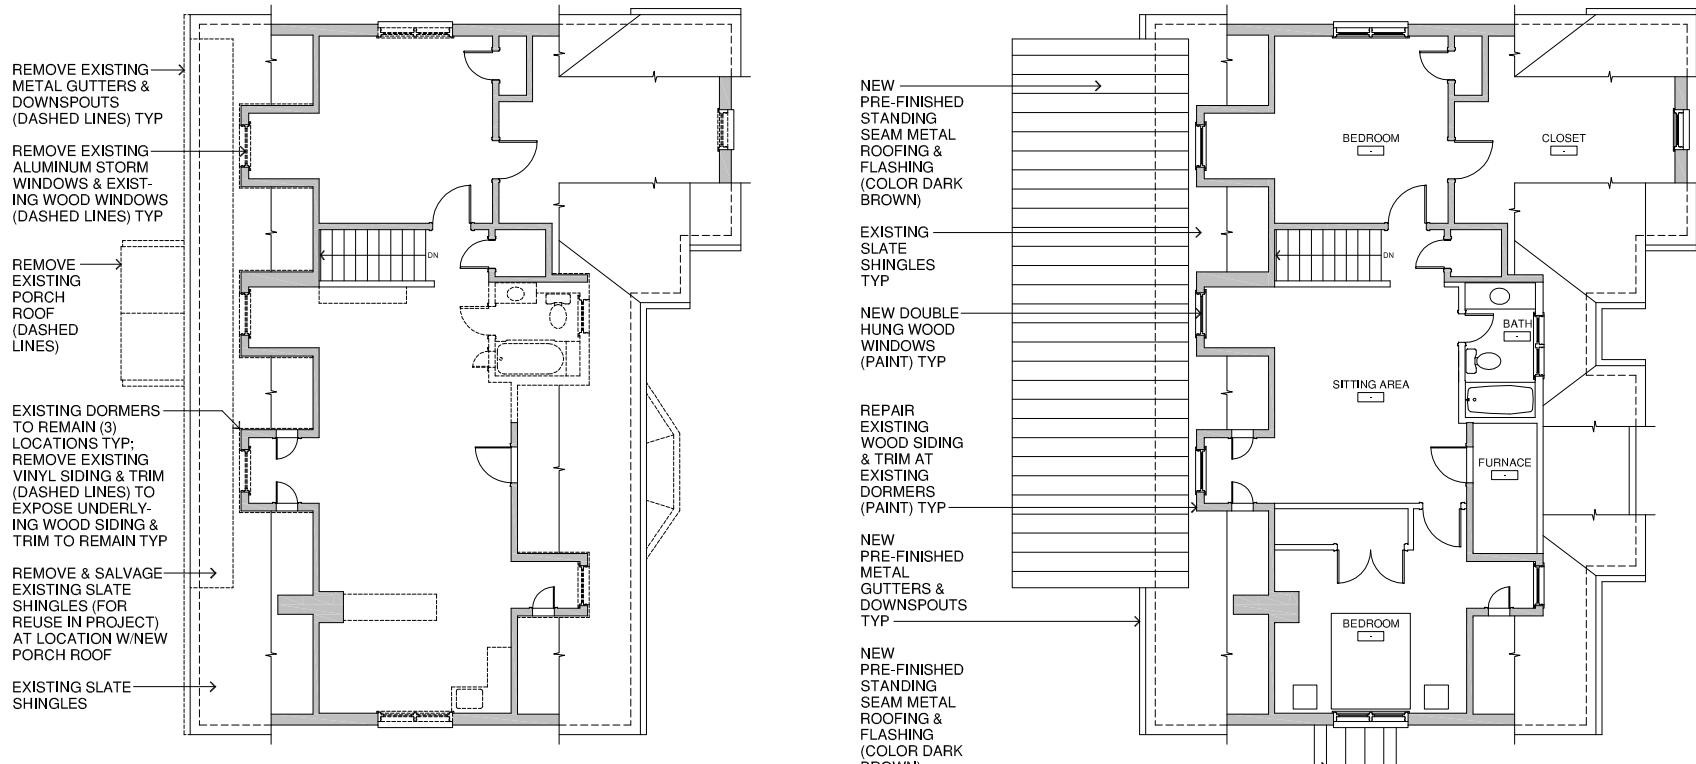
A SECOND FLOOR EXISTING / DEMO PLAN

SCALE: 1/4" = 1'-0"

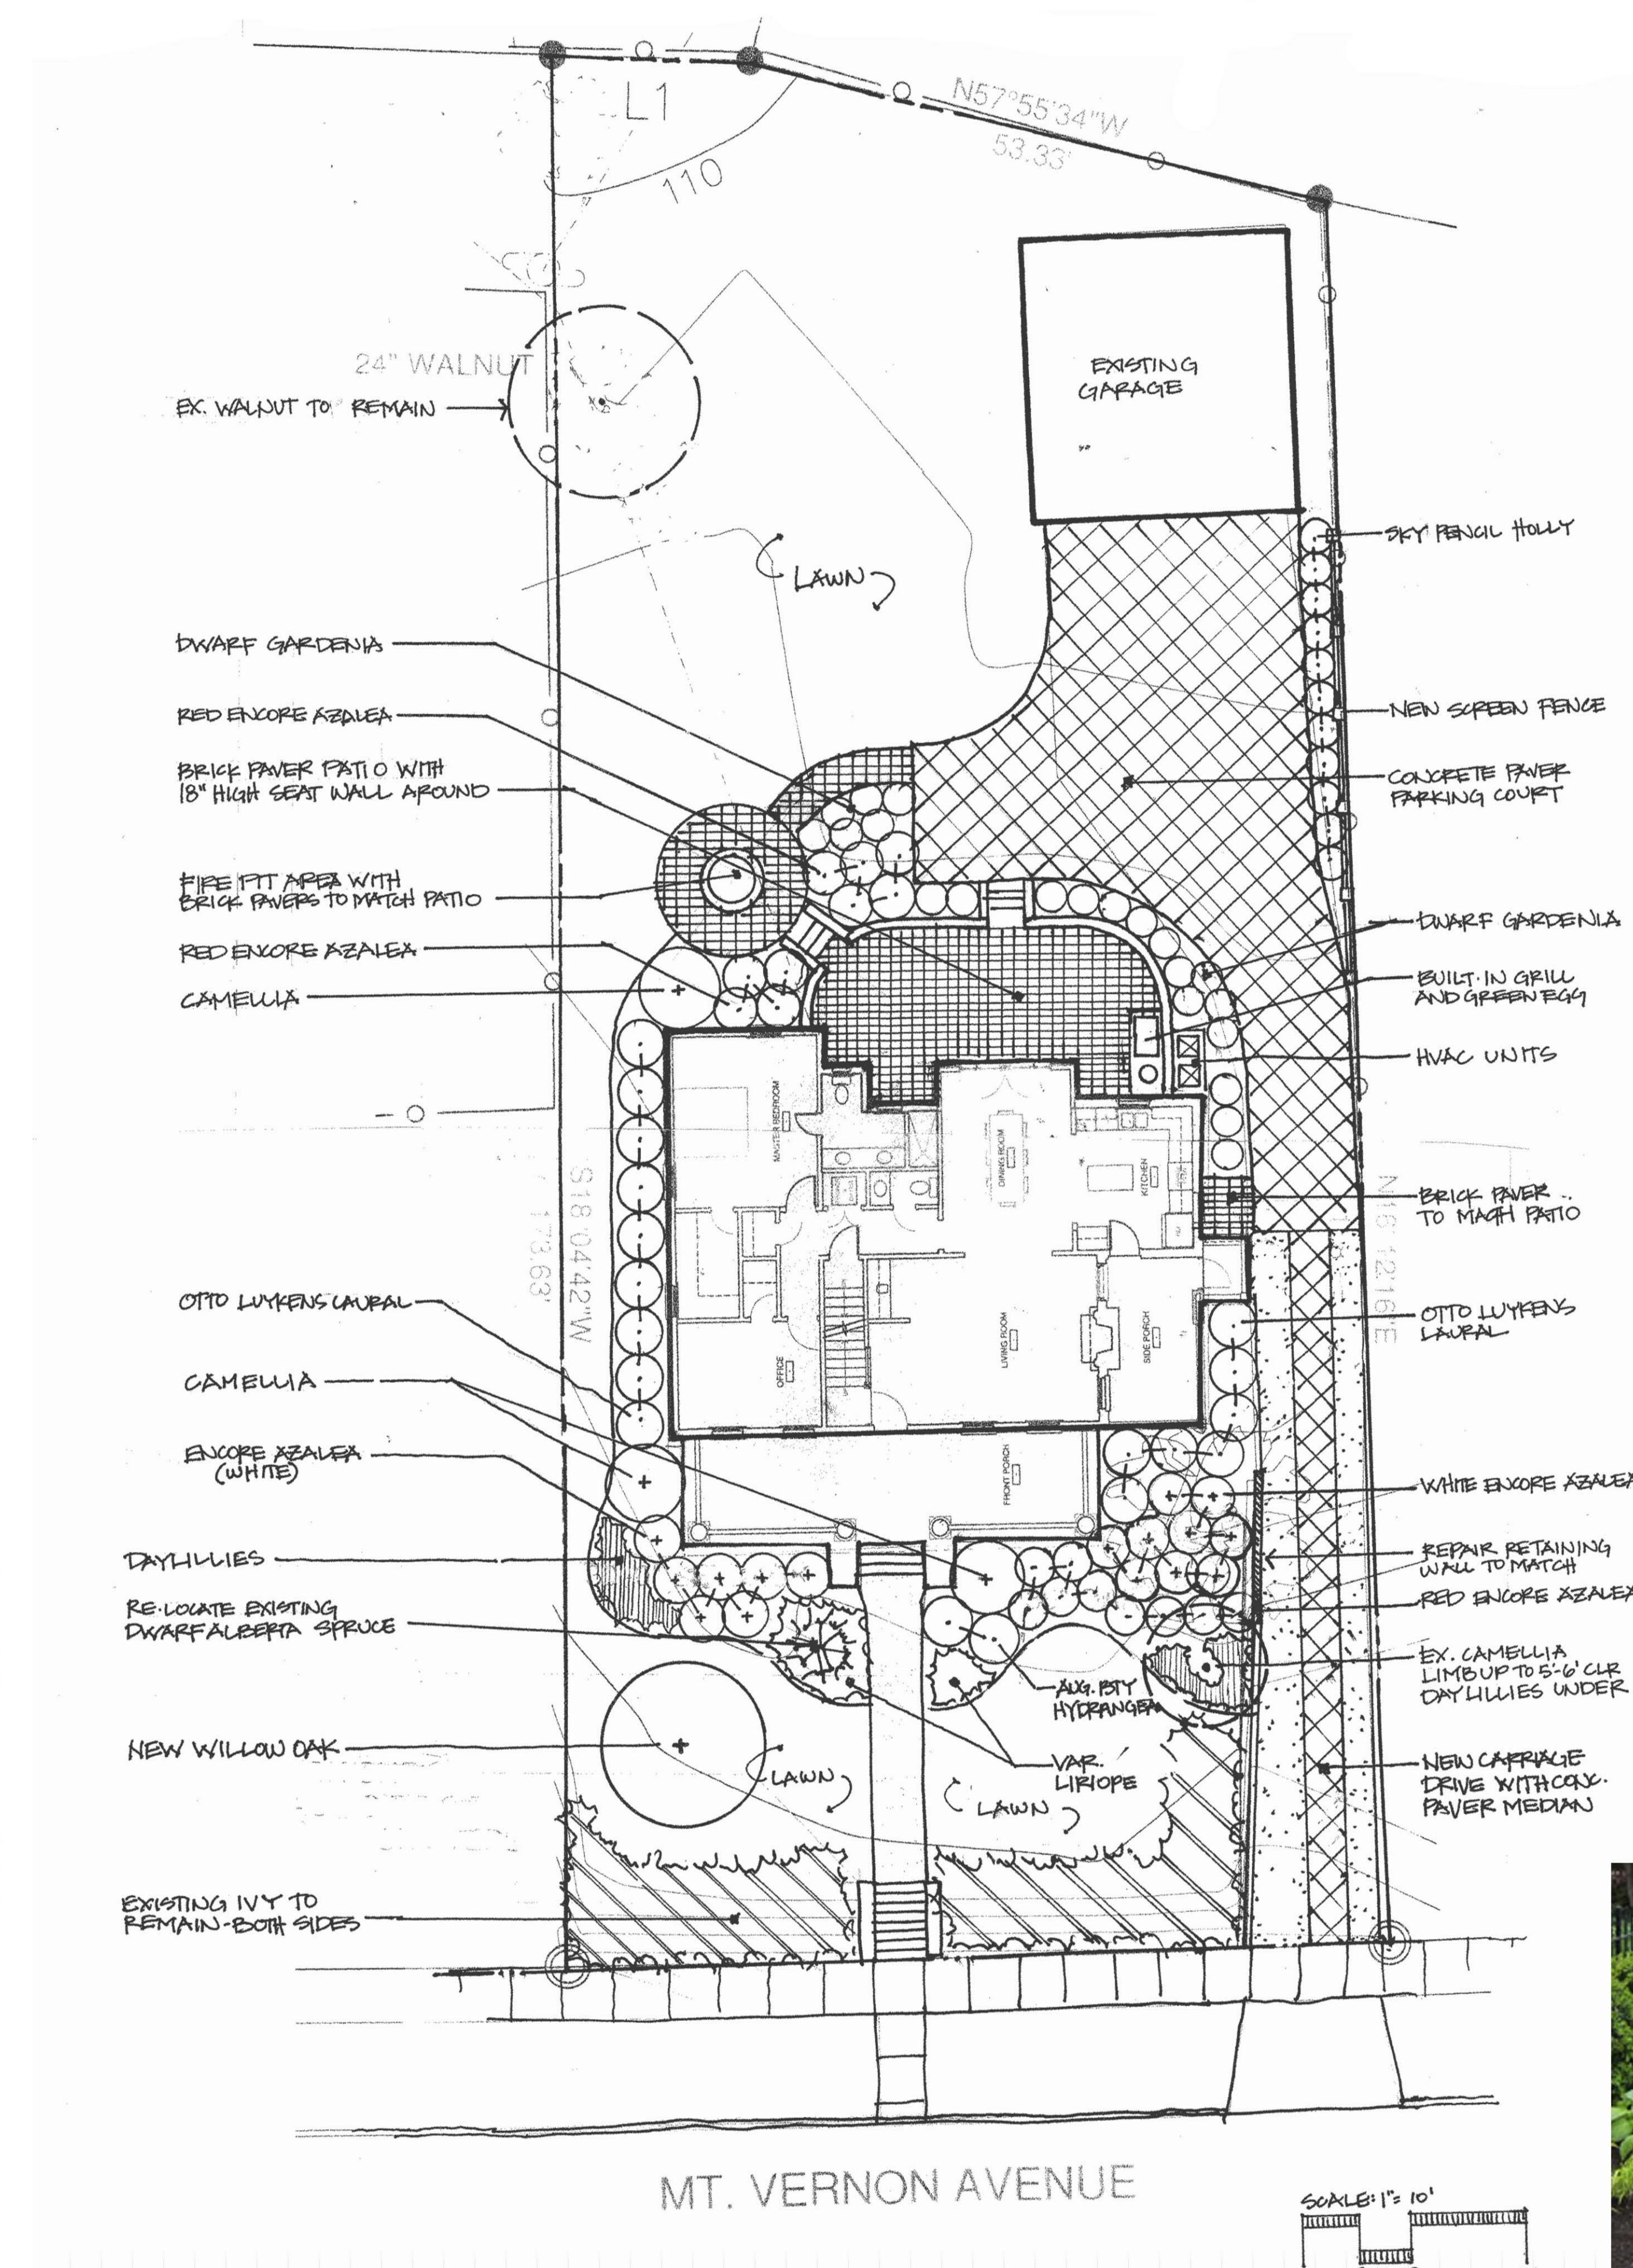
SITE PLAN

BRICK PAVERS

FIRE PIT

BRICK PATIO SND SEAT WALL

6' PRIVACY FENCE

PAVERS PARKING COURT

GREEN EGG WITH GRILL

CONCRETE CARRIAGE DRIVE WITH
CONCRETE PAVER MEDIAN

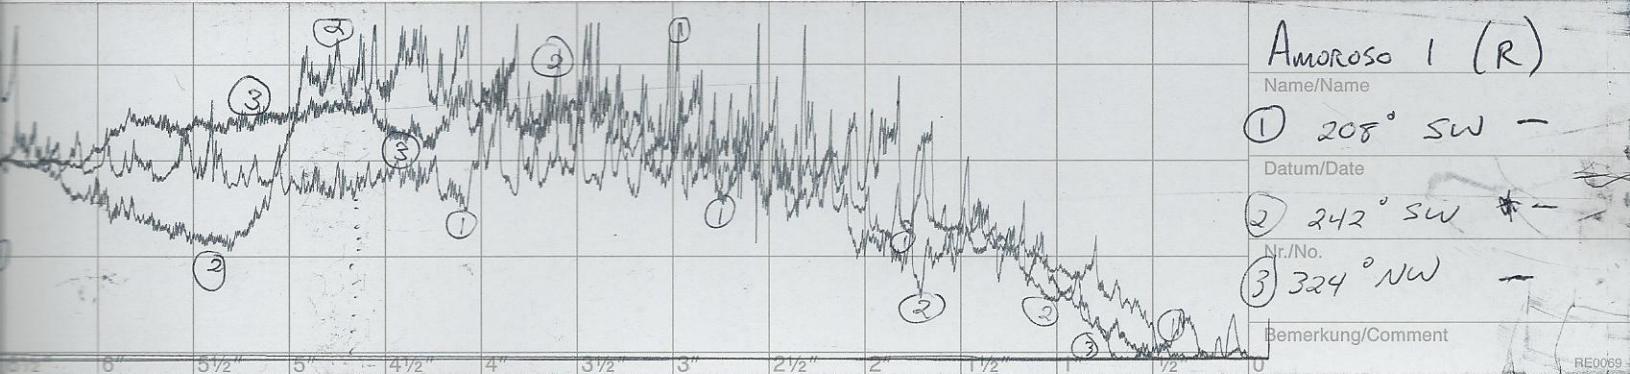
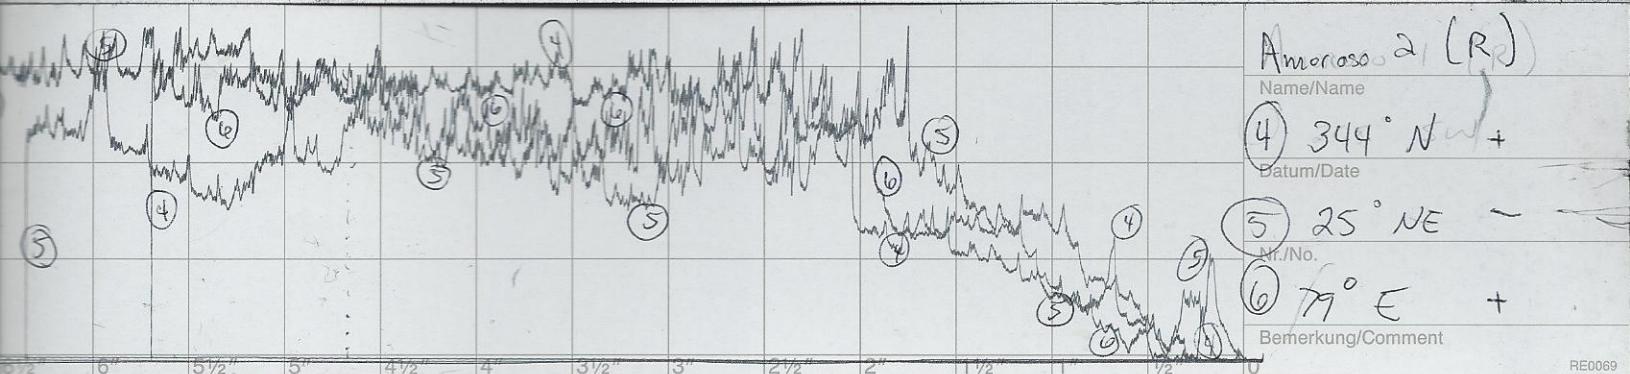
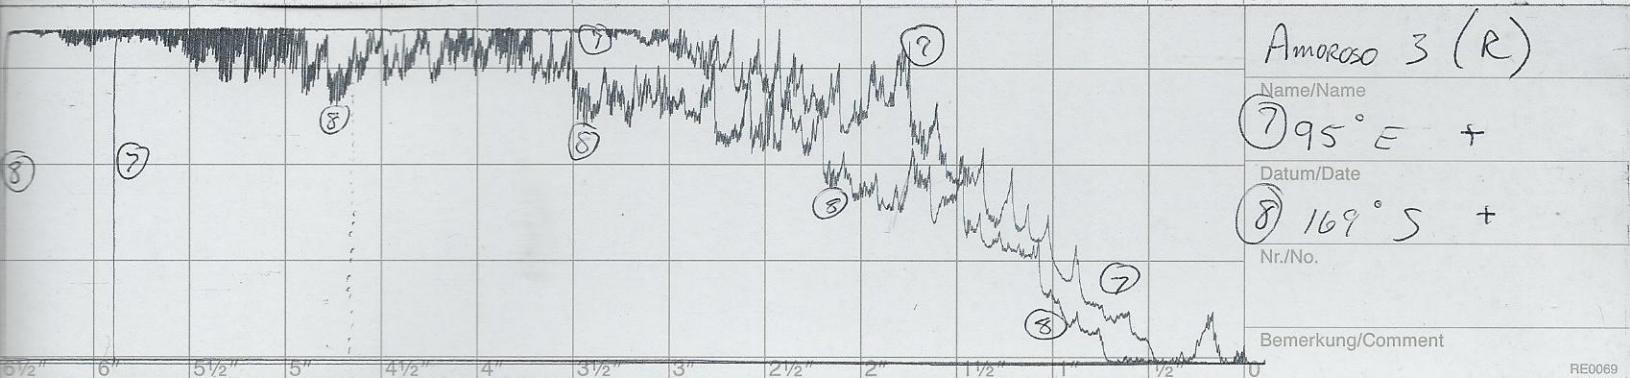
After a limited visual assessment, I performed a percussion test to the lower trunk by sounding it with a rubber mallet. This allowed me to listen for changes in pitch, which is indicative of decay/cavities. An F-300 Resistograph was then used on each tree to graph the internal structure of the wood in the root flare, based on resistance.

The 38" Willow Oak on the left had nine root flares sampled. Four of those sampled "failed", resulting in 44% of the root flare being affected by decay. The 31" Willow Oak on the right had eight root flares sampled. Four of those eight "failed", resulting in 50% of the root flare being affected by decay. Based on these percentages, both trees fail to meet the "acceptable" threshold. Another concern is the plan for future construction to this site. Even if these trees were to be retained for any reason, the impact of construction would only expedite their demise. It is my regret to recommend these trees be removed.

Industry standards state that the ratio of sound minimal shell wall thickness (MSWT), relative to the diameter of the trunk, should not be less than 33%. In addition, there should not be more than 33% of the root flare missing or compromised by cavities. Arborists obtain the MSWT by multiplying the diameter of the trunk by .15.

For example, $(38") \times (.15) = 5.7"$. Each root flare on the tree on the left needs a minimum of 5.7" of sound wood to "pass". If more than 33% of the root flares "fail", then the whole tree "fails".

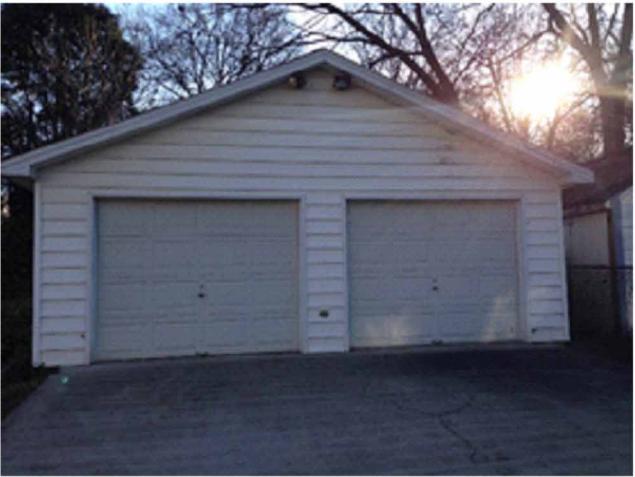
A EXISTING GARAGE DOORS ELEVATION
NOT TO SCALE

REMOVE EXISTING VINYL SIDING (FRONT & YARD SIDE) & METAL DOORS (FRONT SIDE)

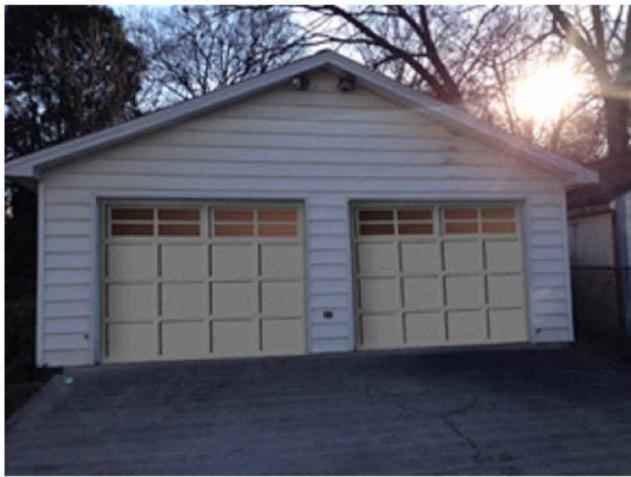
B PROPOSED GARAGE DOORS ELEVATION
NOT TO SCALE

PROVIDE WOOD SIDING (FRONT & YARD SIDE) & WOOD DOORS (FRONT SIDE) PAINT

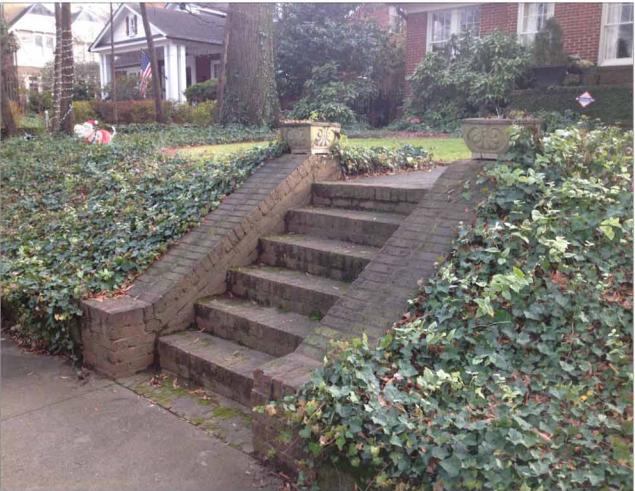
C EXISTING BRICK CHEEK WALLS AT 712 MT VERNON AVE
NOT TO SCALE

PROVIDE BRICK CHEEK WALLS (AT STEPS TO SIDEWALK) SIMILAR TO THESE

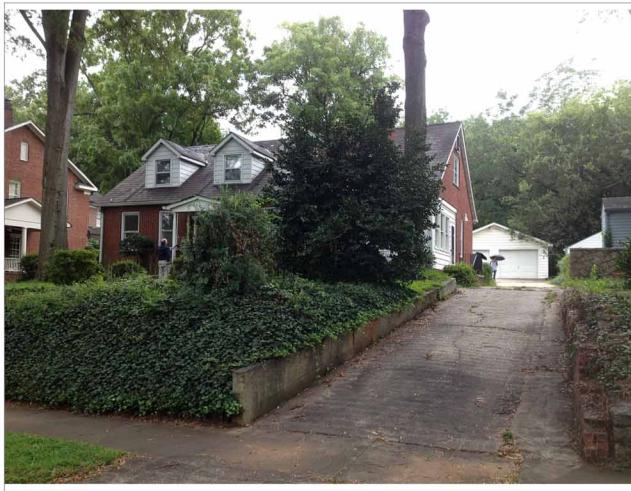
D EXISTING VIEW OF GARAGE FROM STREET
NOT TO SCALE
