LOCAL HISTORIC DISTRICT: Wesley Heights

PROPERTY ADDRESS: 408 Walnut Avenue

SUMMARY OF REQUEST: Tree removal and site features

Pecan at 408 Walnut Ave Tree Risk Assessment

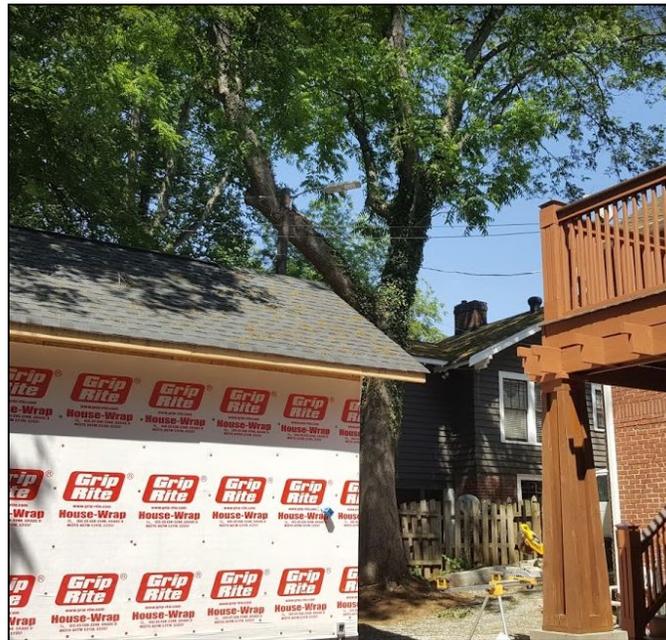
Figure 1: Pecan tree under investigation

The tree in question is a mature 31-inch at 4.5ft from grade (DBH) pecan (*Carya illinoniesis*) (Figure 1). One structural root has recently been severed on the north west side of the tree (Figure 3). There are signs of root decay/damage on the south west side of the tree (Figure 2). There are signs of reaction wood growing around the wound, which is a sign of good tree vigor. After some excavation with a soil knife evidence of past structural root severance was revealed along the western side of the tree approximately 22-inches from the root flare (Figure 3). These roots appeared dead and were in various stages of decay.

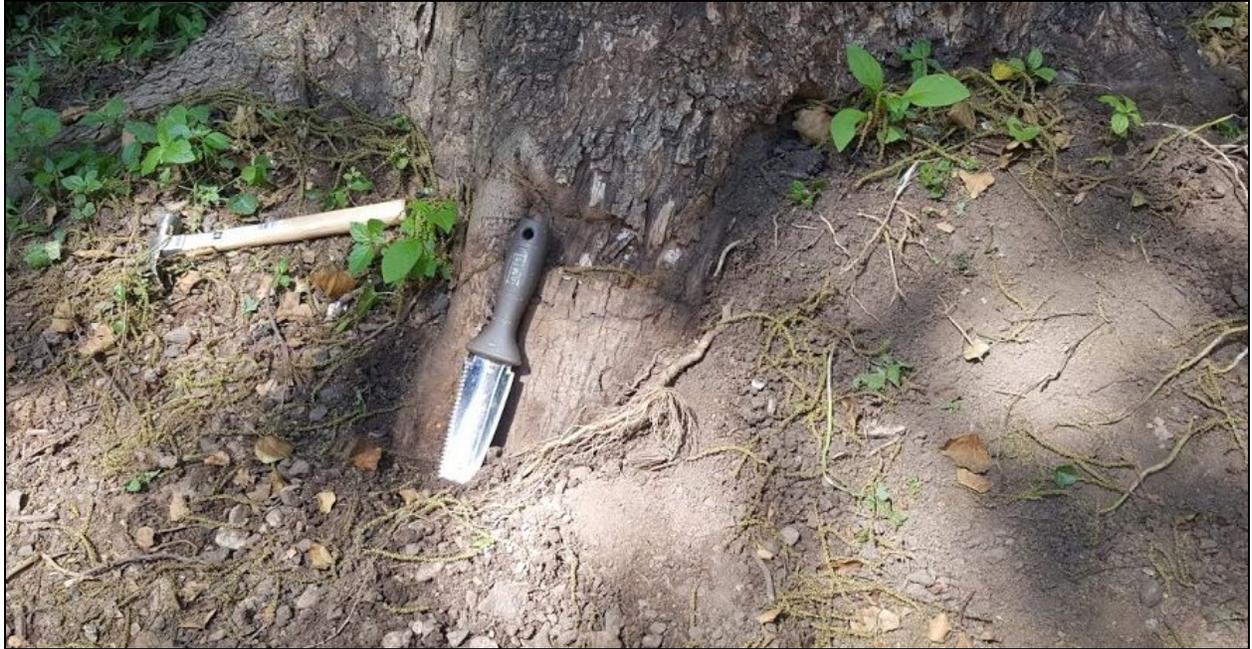
Figure 2: Damaged/decayed root on south west side of tree

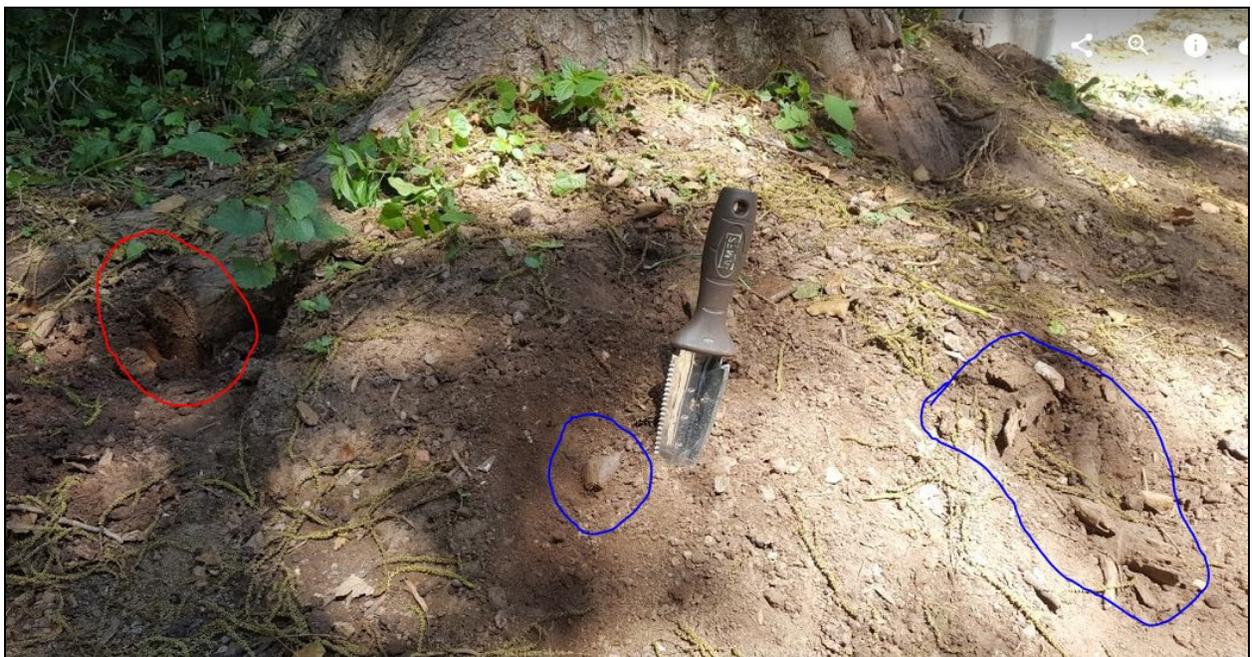
Figure 3: Recently severed root (circled red) and past severed roots (circled blue)

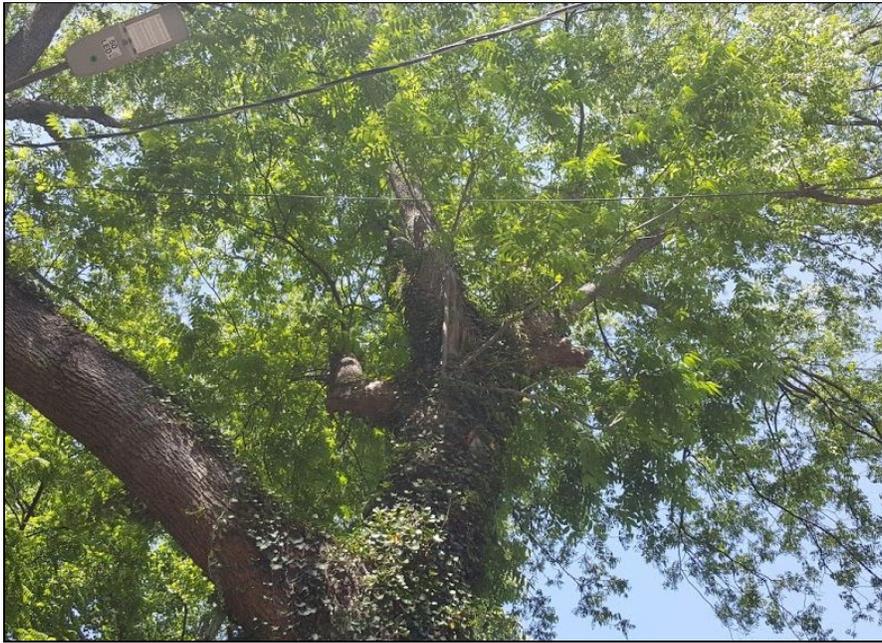
Figure 4: Past limb failure and cavity

The crown of the tree is asymmetric with crown weight distributed on the eastern side of the tree. There are signs of past limb failure within the crown of the tree. On the south western side of the crown/trunk there is evidence of a past large limb failure with associated cavity/decay (Figure 4). There is a dynamic cable system installed within two large limbs within this area, which should

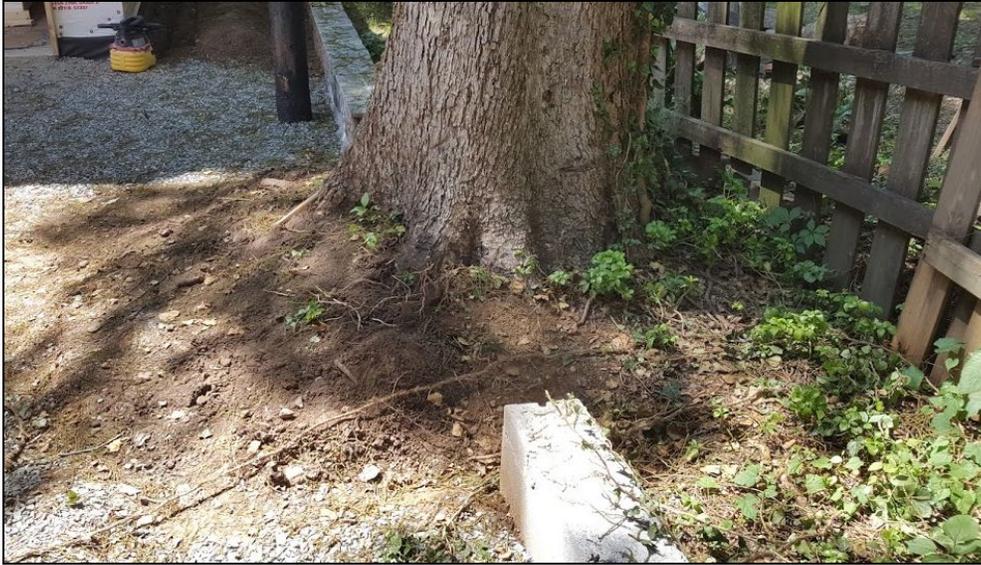
Figure 5: Area around pecan

The pecan is growing between the driveway of 408 Walnut Ave and the residence of 404 Walnut Ave. The root flare/structural root system of the tree interacts with the driveway of 408 Walnut Ave and is approximately 7.5ft from the residence of 404 Walnut Ave (Figure 5).

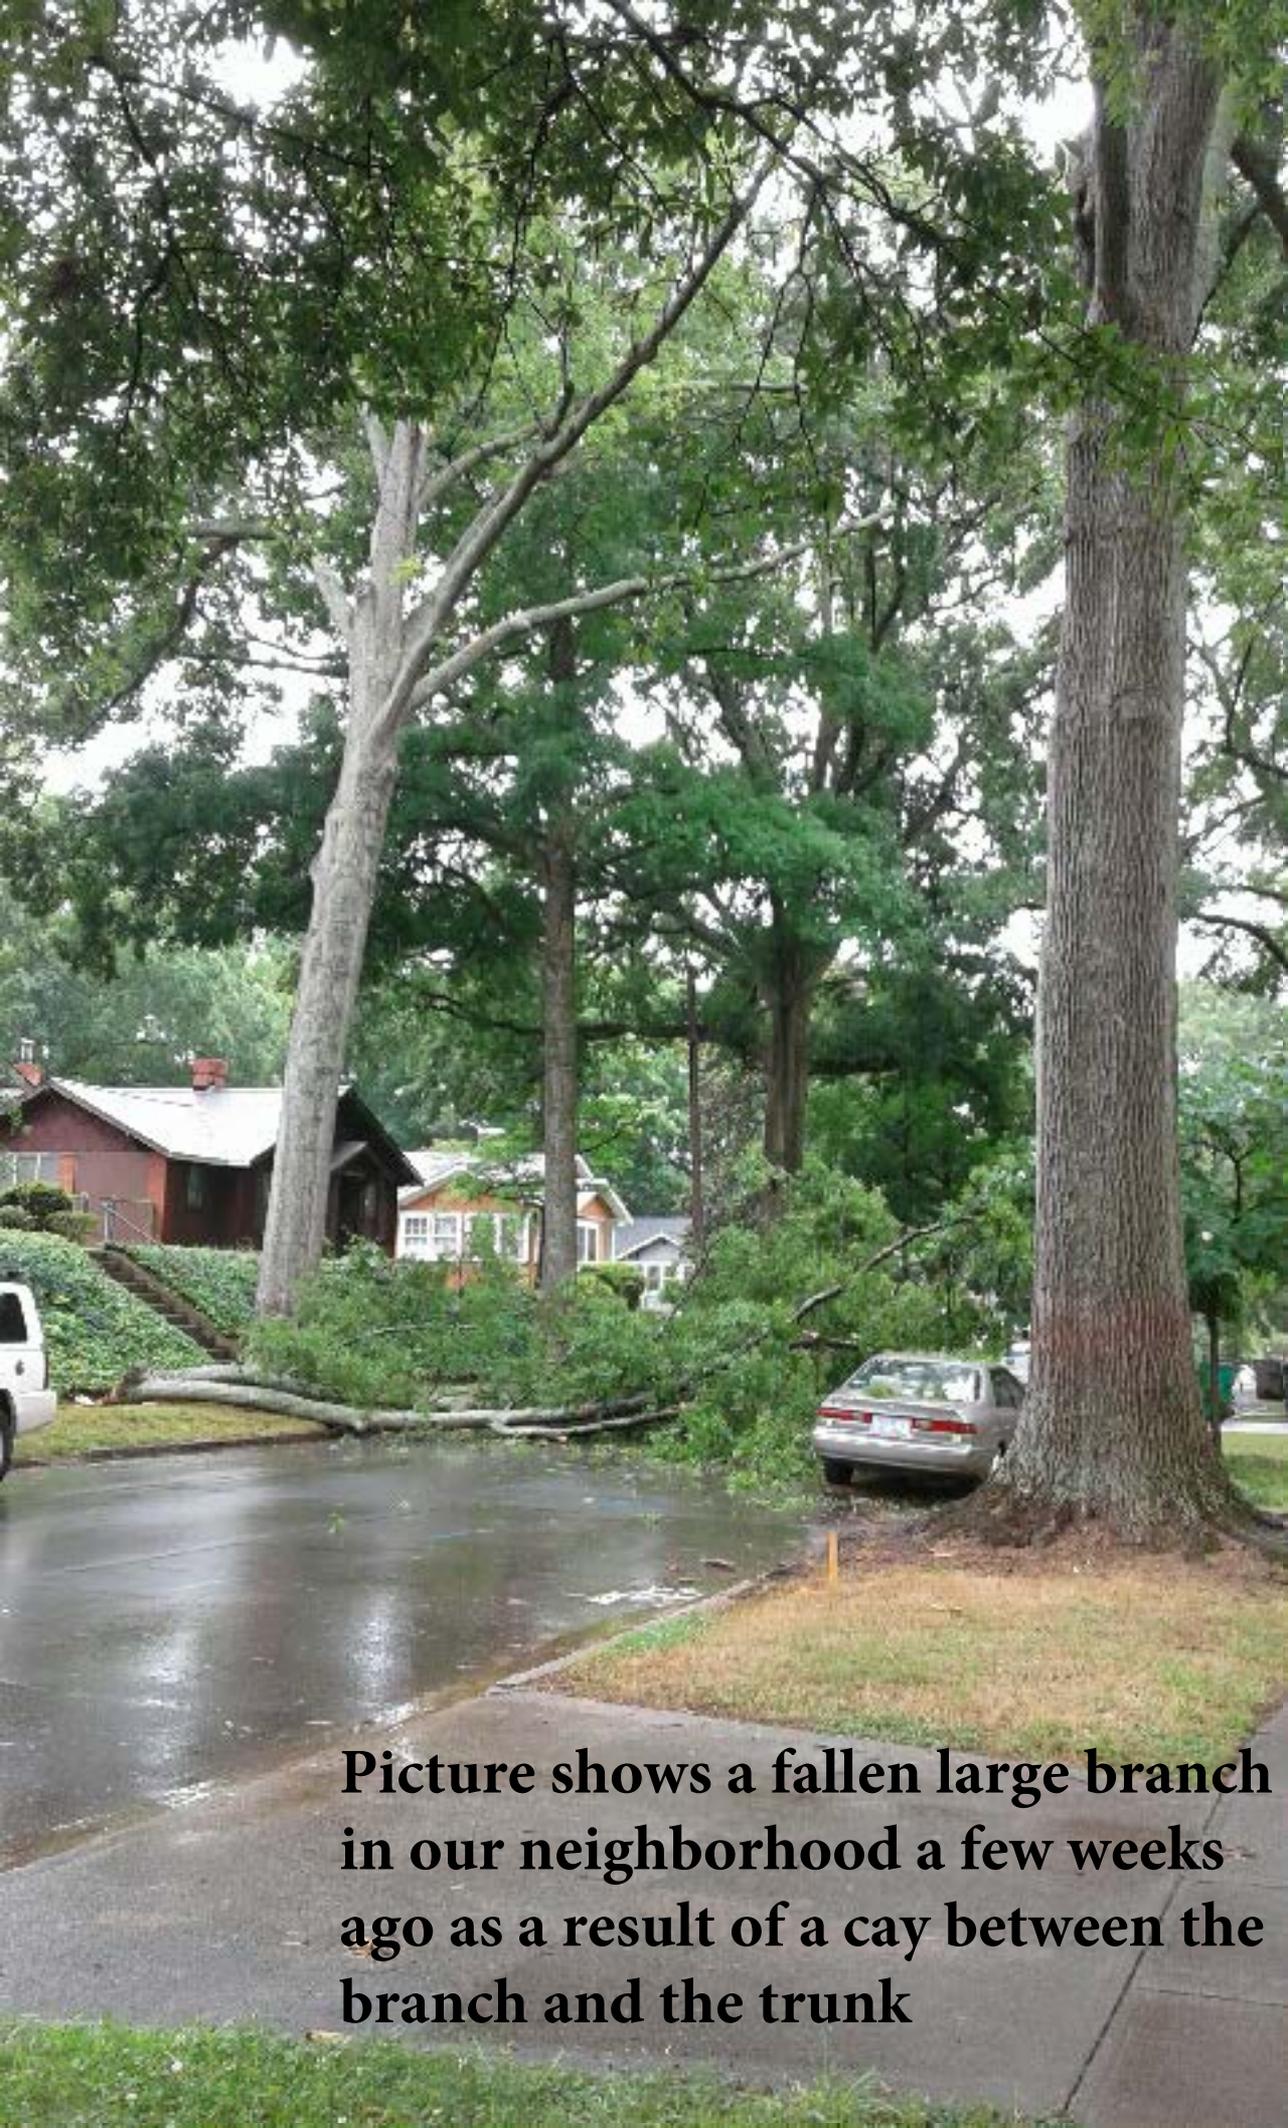
Picture shows a fallen large branch in our neighborhood a few weeks ago as a result of a cay between the branch and the trunk

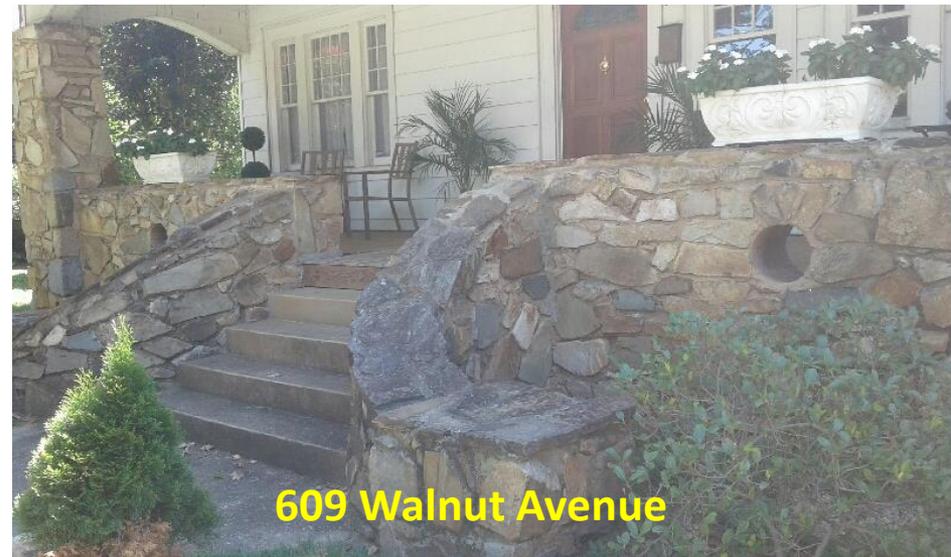
609 Walnut Avenue

EXAMPLES OF STONE IN WESLEY HEIGHTS

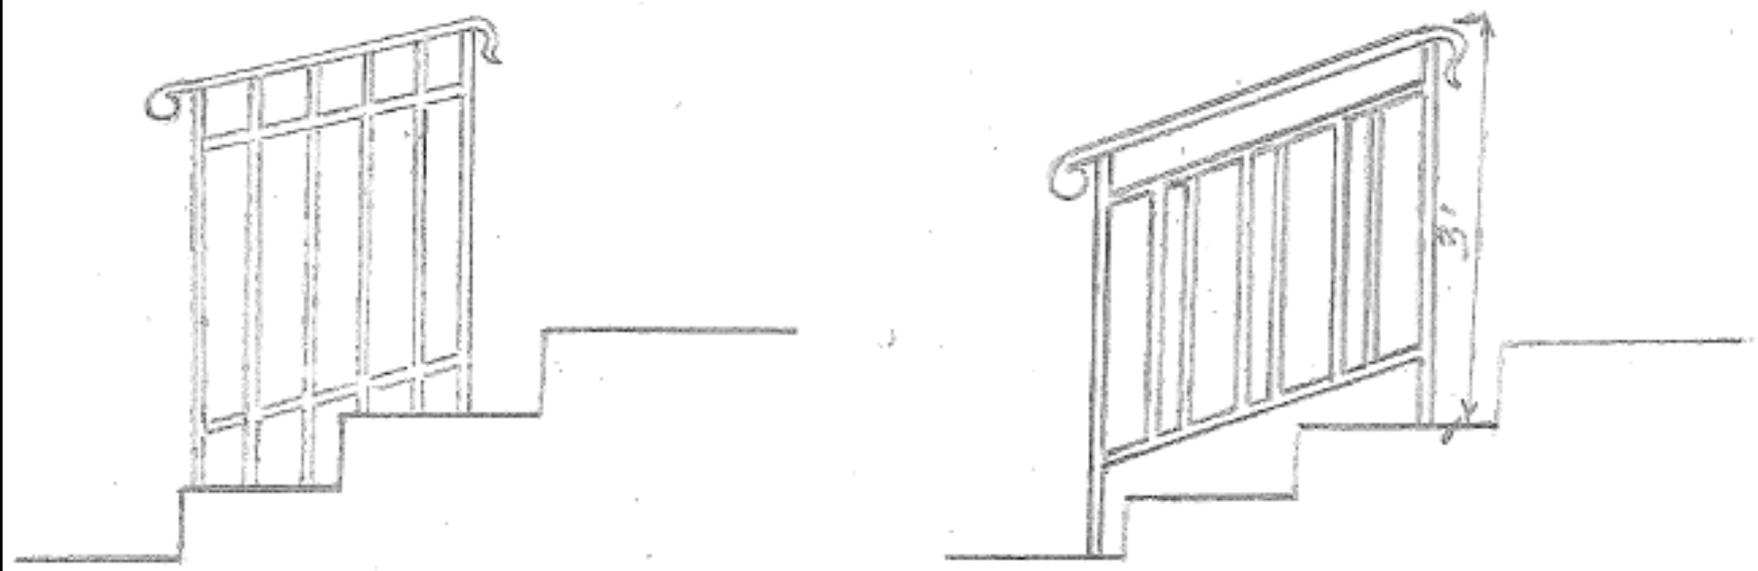
IRON RAILINGS IN FRONT OF PORCH

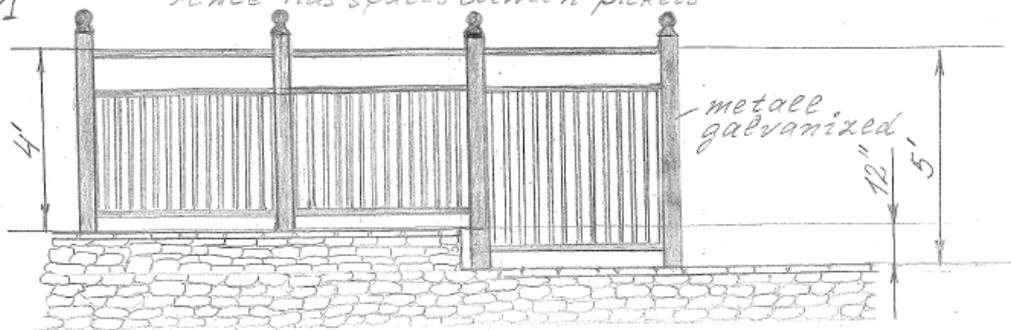
1

Fence has spaces between pickets

- ① fence around backyard
- ② - gate to driveway
- ③ - fence and small gate to garden
