APPLICANT/OWNER:	Joshua Stewart / Johnatan Romero
SUMMARY OF REQUEST:	New Construction
PROPERTY ADDRESS:	612 South Summit Avenue
LOCAL HISTORIC DISTRICT:	Wesley Heights

### HDCRMA 2019-00588 PID: 07102331 LOCAL HISTORIC DISTRICT: WESLEY HEIGHTS PROPOSED PROJECT: NEW CONSTRUCTION

## **Romero Bungalow**

# Historic District Commission Presentation (Continued)

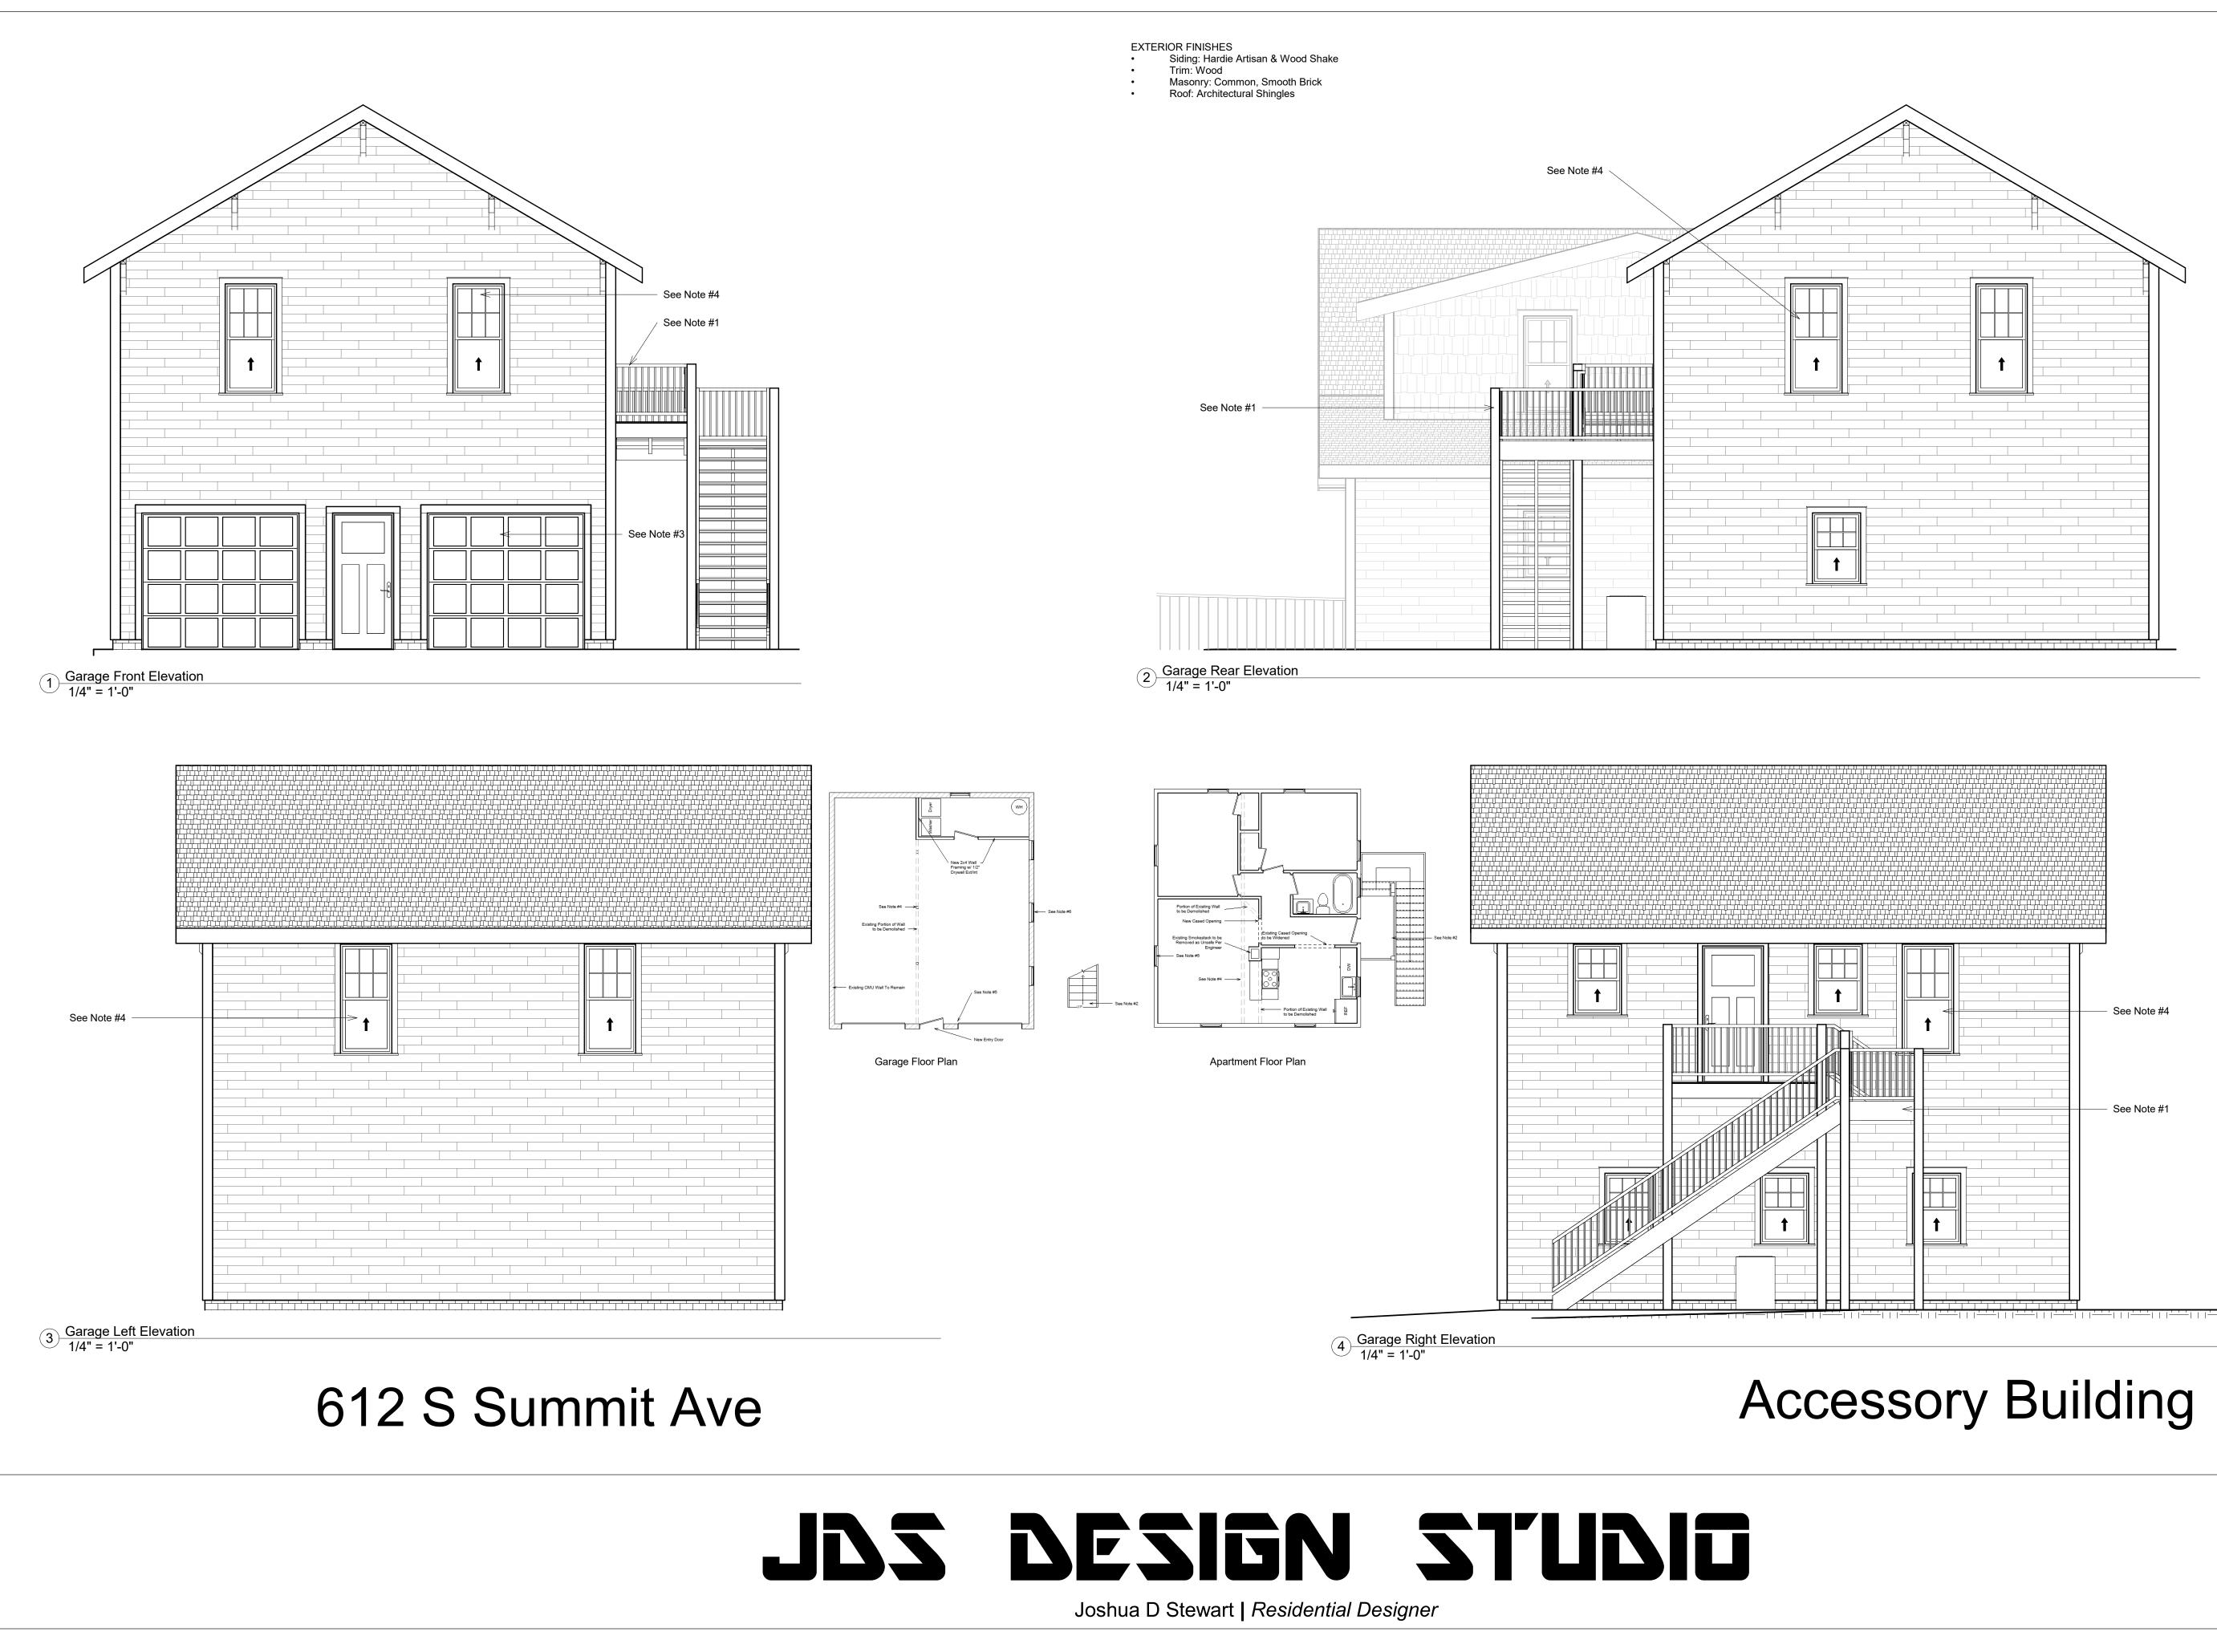
1) DIMENSIONS REFERENCE FACE OF STUD OR CMU BLOCK AND FINISHED OR JAMB OPENING.

2) EXISTING STAIRS AND PORCH STRUCTURE TO BE DEMOLISHED. SEE ENGINEER NOTES/DRAWINGS FOR NEW STAIRS AND PORCH STRUCTURE.

5) EXISTING, NON-ORIGINAL DOOR OPENING TO BE RE-SIZED FOR STANDARD GARAGE DOOR AND RE-CENTERED FOR EQUAL SPACING ON FRONT ELEVATION.

6) EXISTING, BROKEN/DAMAGED WINDOWS TO BE REPLACED.
