**LOCAL HISTORIC DISTRICT:** Wilmore

**PROPERTY ADDRESS:** 1529 and 1537 South Mint Street

**SUMMARY OF REQUEST:** Commercial building rehabilitation (fenestration, murals, signage, awnings, lighting)

# HDCCMA 2019-00529

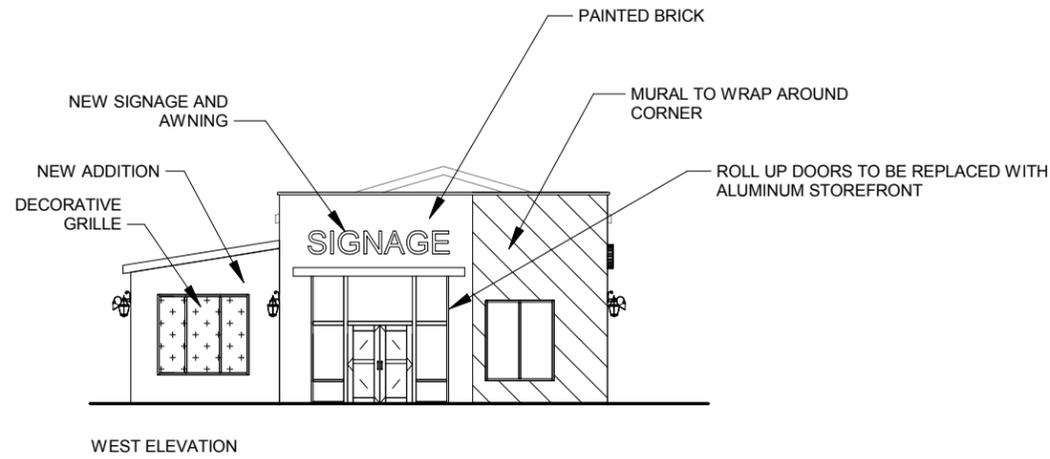
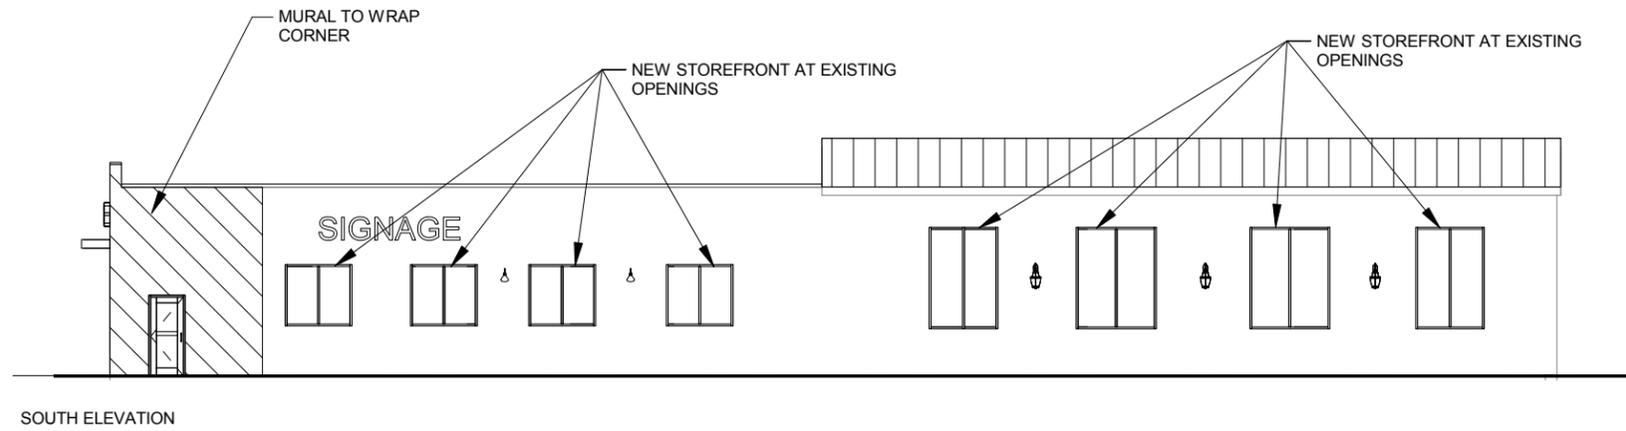
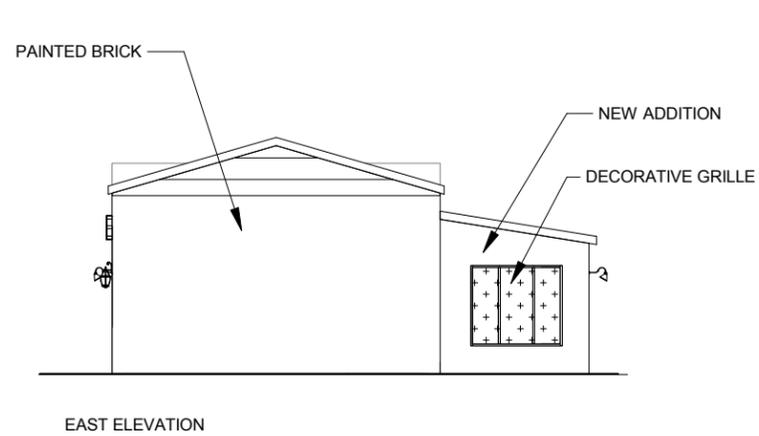
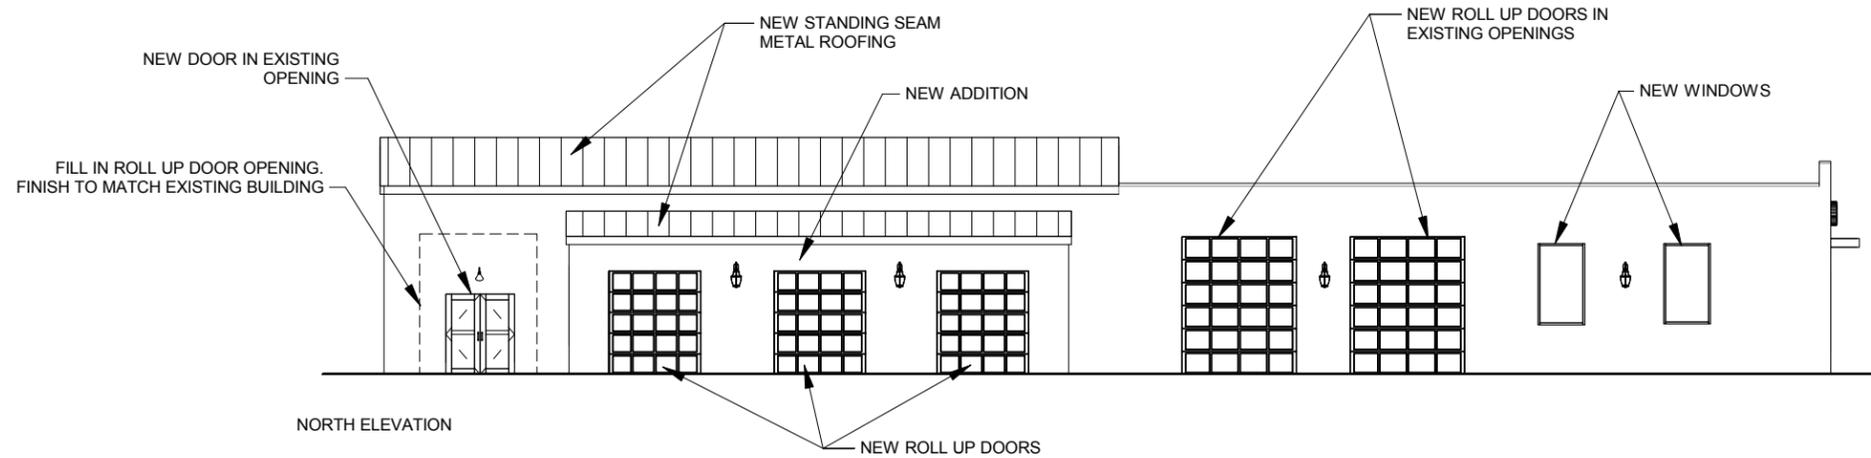
HDC Elevations

1529 South Mint Street  
Charlotte, NC

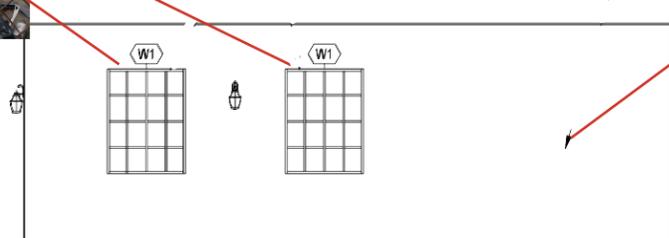
MURAL TO WRAP AROUND CORNER

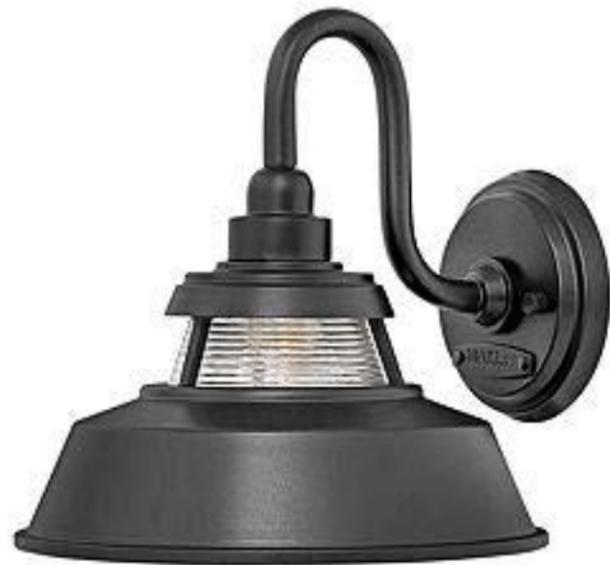
Black  
10" x 10"  
11" from wall  
5" Backplate

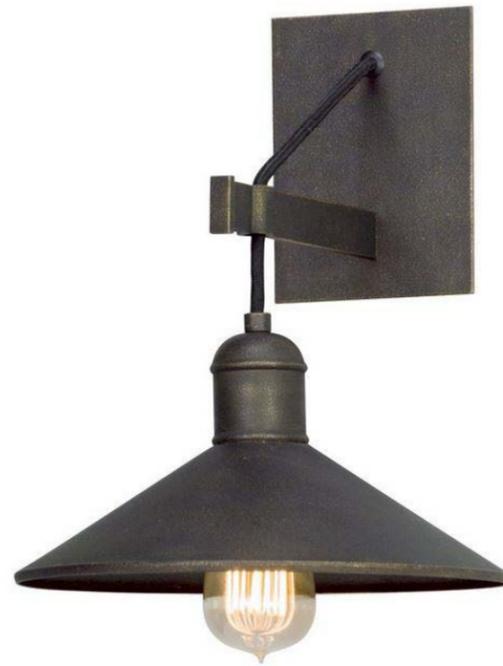
Aluminum  
18" x 14"  
20" from wall  
3" x 10" Backplate

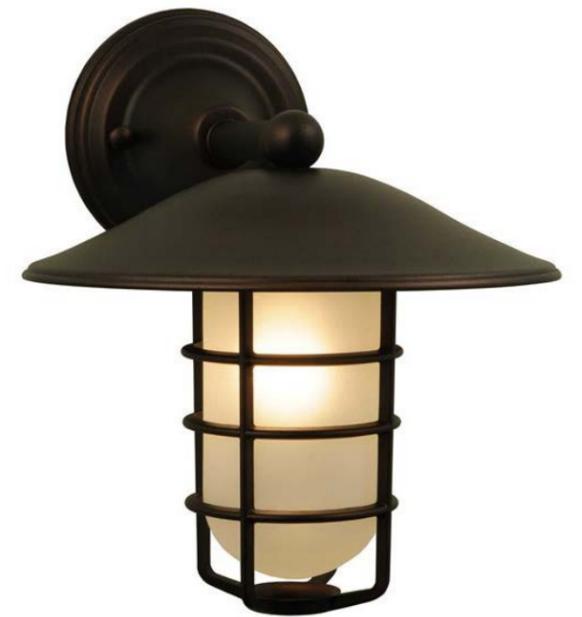
Black  
16.75" x 14"  
22.5" from wall  
6.75" Backplate

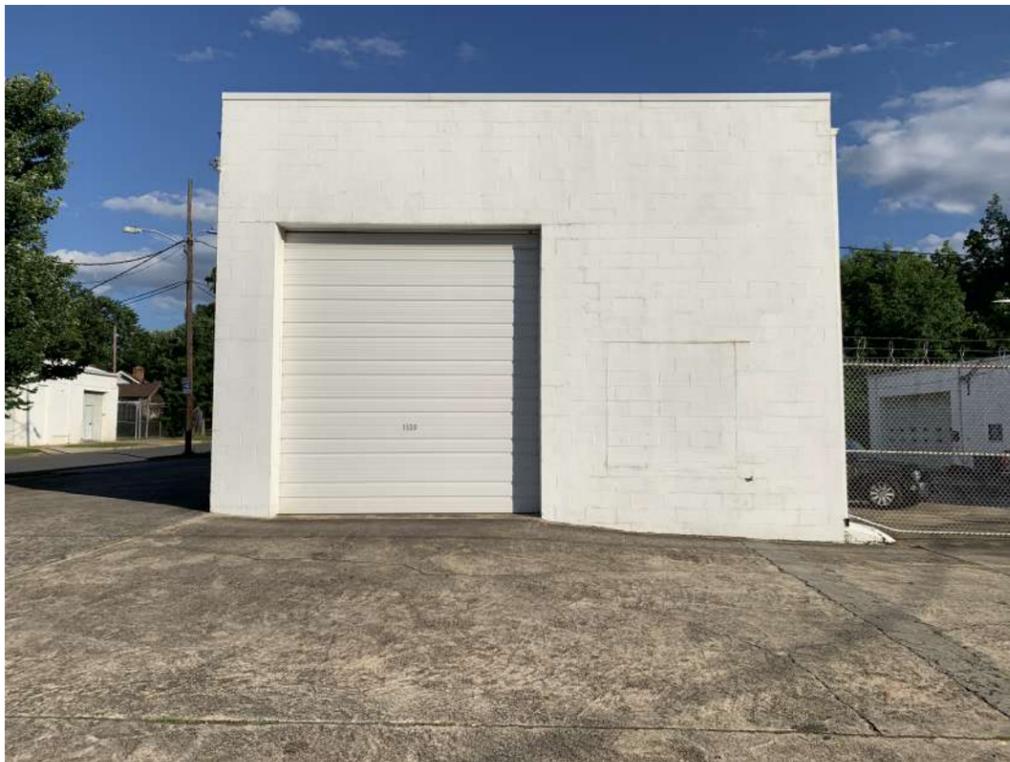
Front Facade

Existing Exterior Conditions ODA
