## Charlotte Historic District Commission

# Application for a Certificate of Appropriateness

ADDRESS OF PROPERTY 1432 Pecan Avenue, Plaza Midwood Local Historic District HDC 2012-010

SUMMARY OF REQUEST Tree Removal

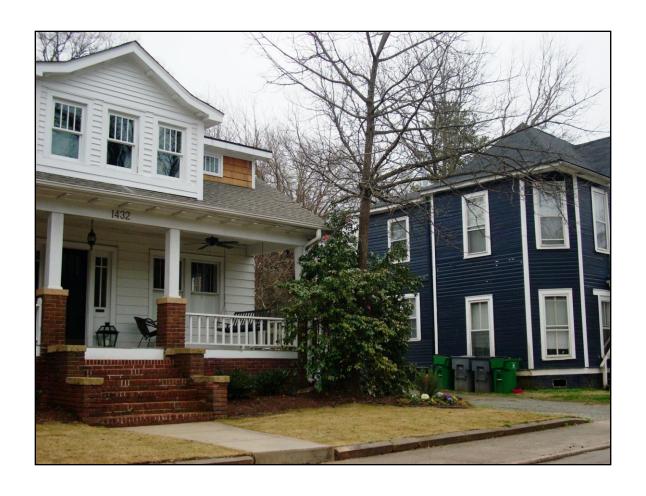
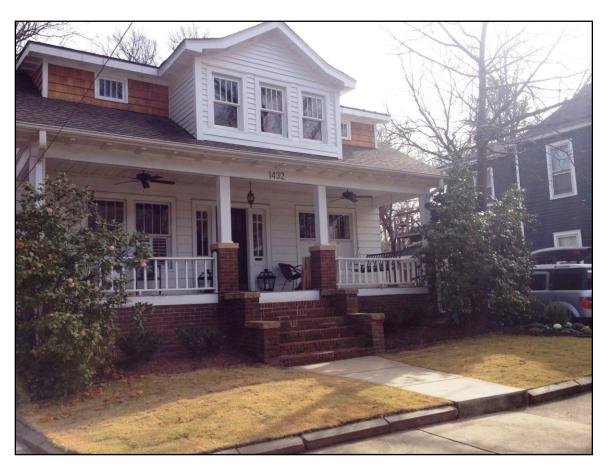
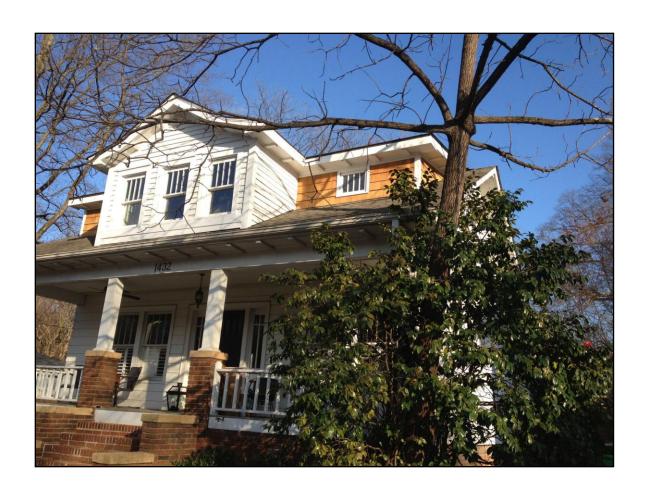
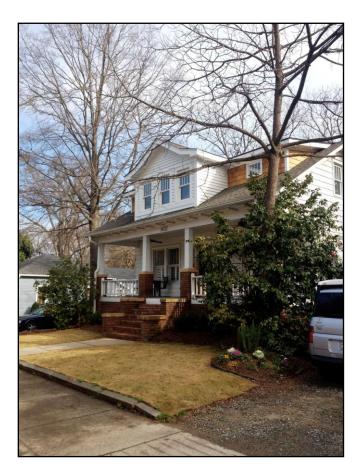
The walnut tree at the front right corner of the house is growing immediately adjacent to the corner of the front porch, and is starting to cause the foundation of the porch to shift.

It is the applicant's contention that the front yard of this house is too small to accommodate a large maturing tree. The attached photos show the front of the house. As near as Staff can estimate, the setback from the sidewalk to the porch foundation appears to be approximately fifteen feet. The distance from the sidewalk to the base of the front steps is roughly eleven feet.

Staff agrees that the location of the tree is causing damage to the foundation of the porch that will only get worse as time progresses. However, the HDC must determine if there is or is not adequate space in the front yard to plant a large-maturing replacement tree.

The property owners approached HDC Staff to discuss removal of the tree to alleviate the damage to the foundation, and Staff explained that the usual procedure, especially in a front yard, is to require the planting of a new large-maturing tree to mitigate the loss of a tree that is necessary to remove. The applicants have filed this application to seek a waiver of that Staff level requirement.
