Charlotte Historic District Commission Application for a Certificate of Appropriateness

HDC 2017-012
 PID# 11907910

PROPERTY ADDRESS: 247 West Kingston Avenue

SUMMARY OF REQUEST: Addition

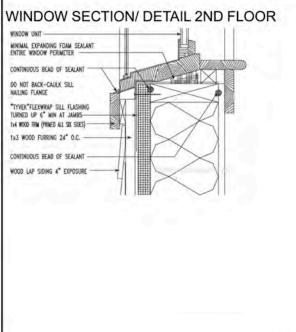
PROPOSED

WEST KINGSTON AVENUE

- 1. The left side dormer has been revised.
- 2. The rear roof forms have been revised to a hip style on the first and second level.
- 3. The retaining wall designs have been revised.
