**LOCAL HISTORIC DISTRICT:** Hermitage Court

**PROPERTY ADDRESS:** 121 Hermitage Road

**SUMMARY OF REQUEST:** Material change on accessory building

*Charlotte Historic District Commission Case 2017-277*  
**HISTORIC DISTRICT: Hermitage Court**  
**ROOF REPLACEMENT**

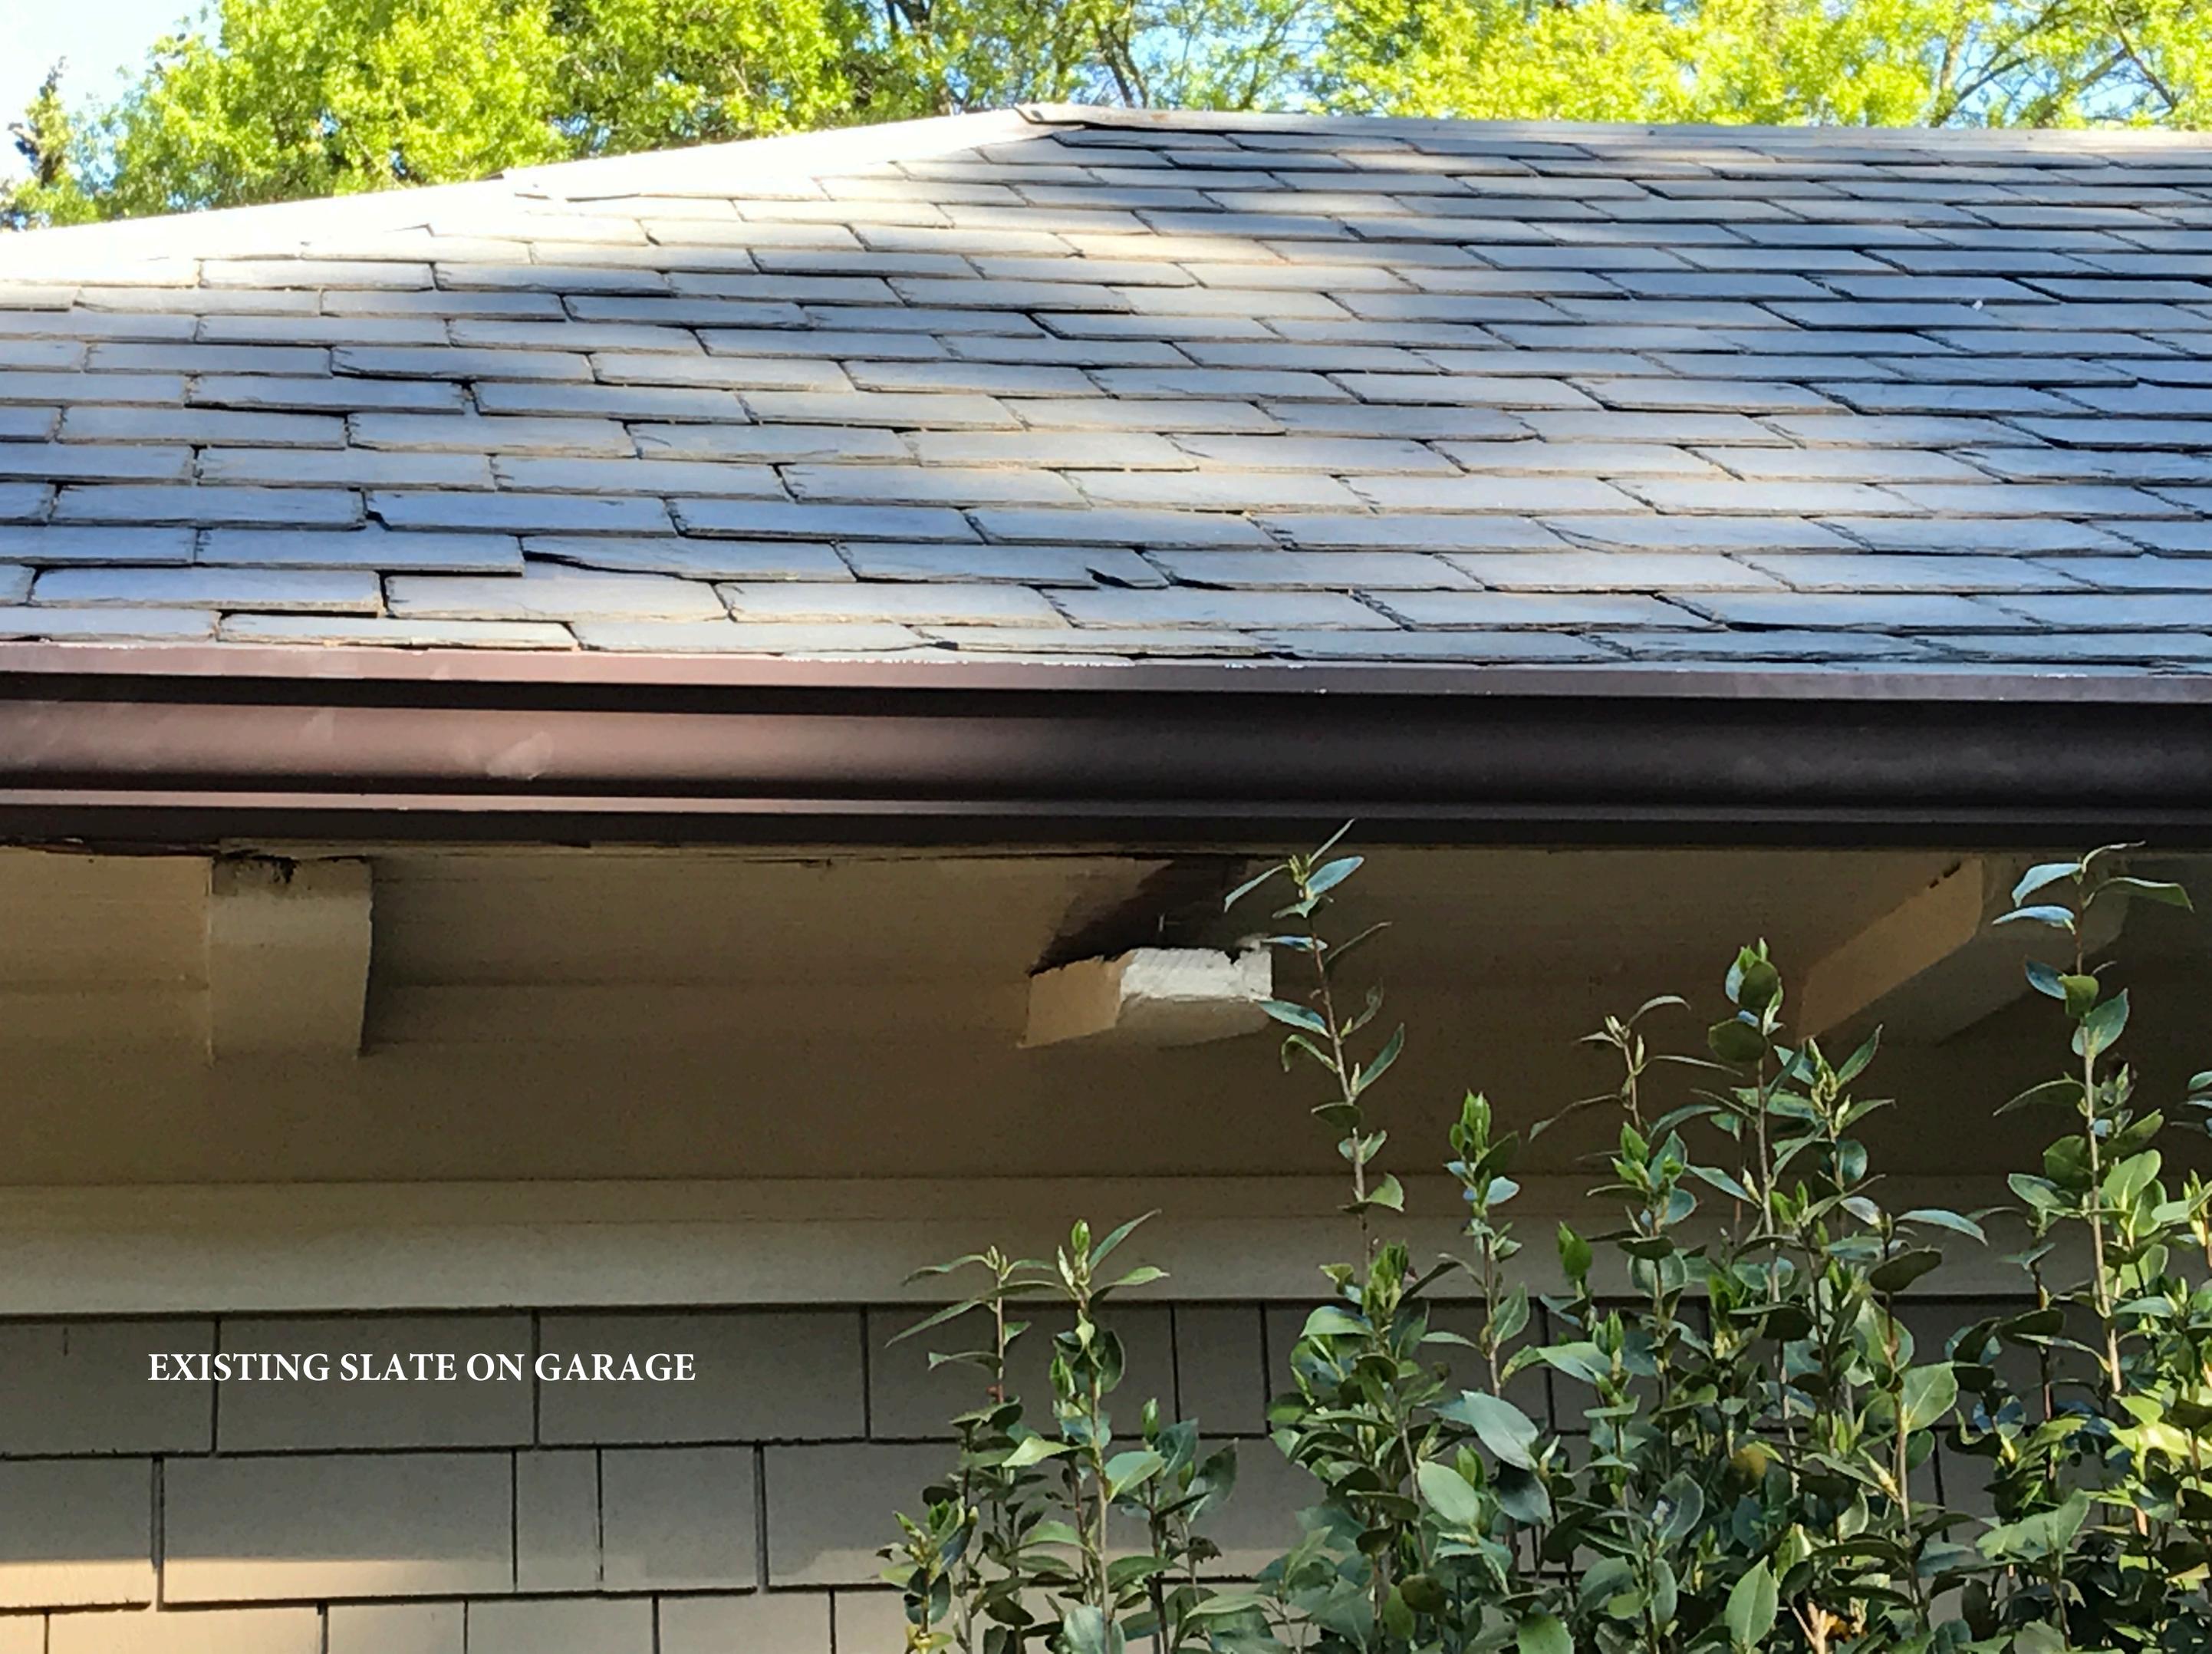
EXISTING SLATE ON GARAGE

The proposal is the replacement of the slate roof on the accessory building with architectural shingles.

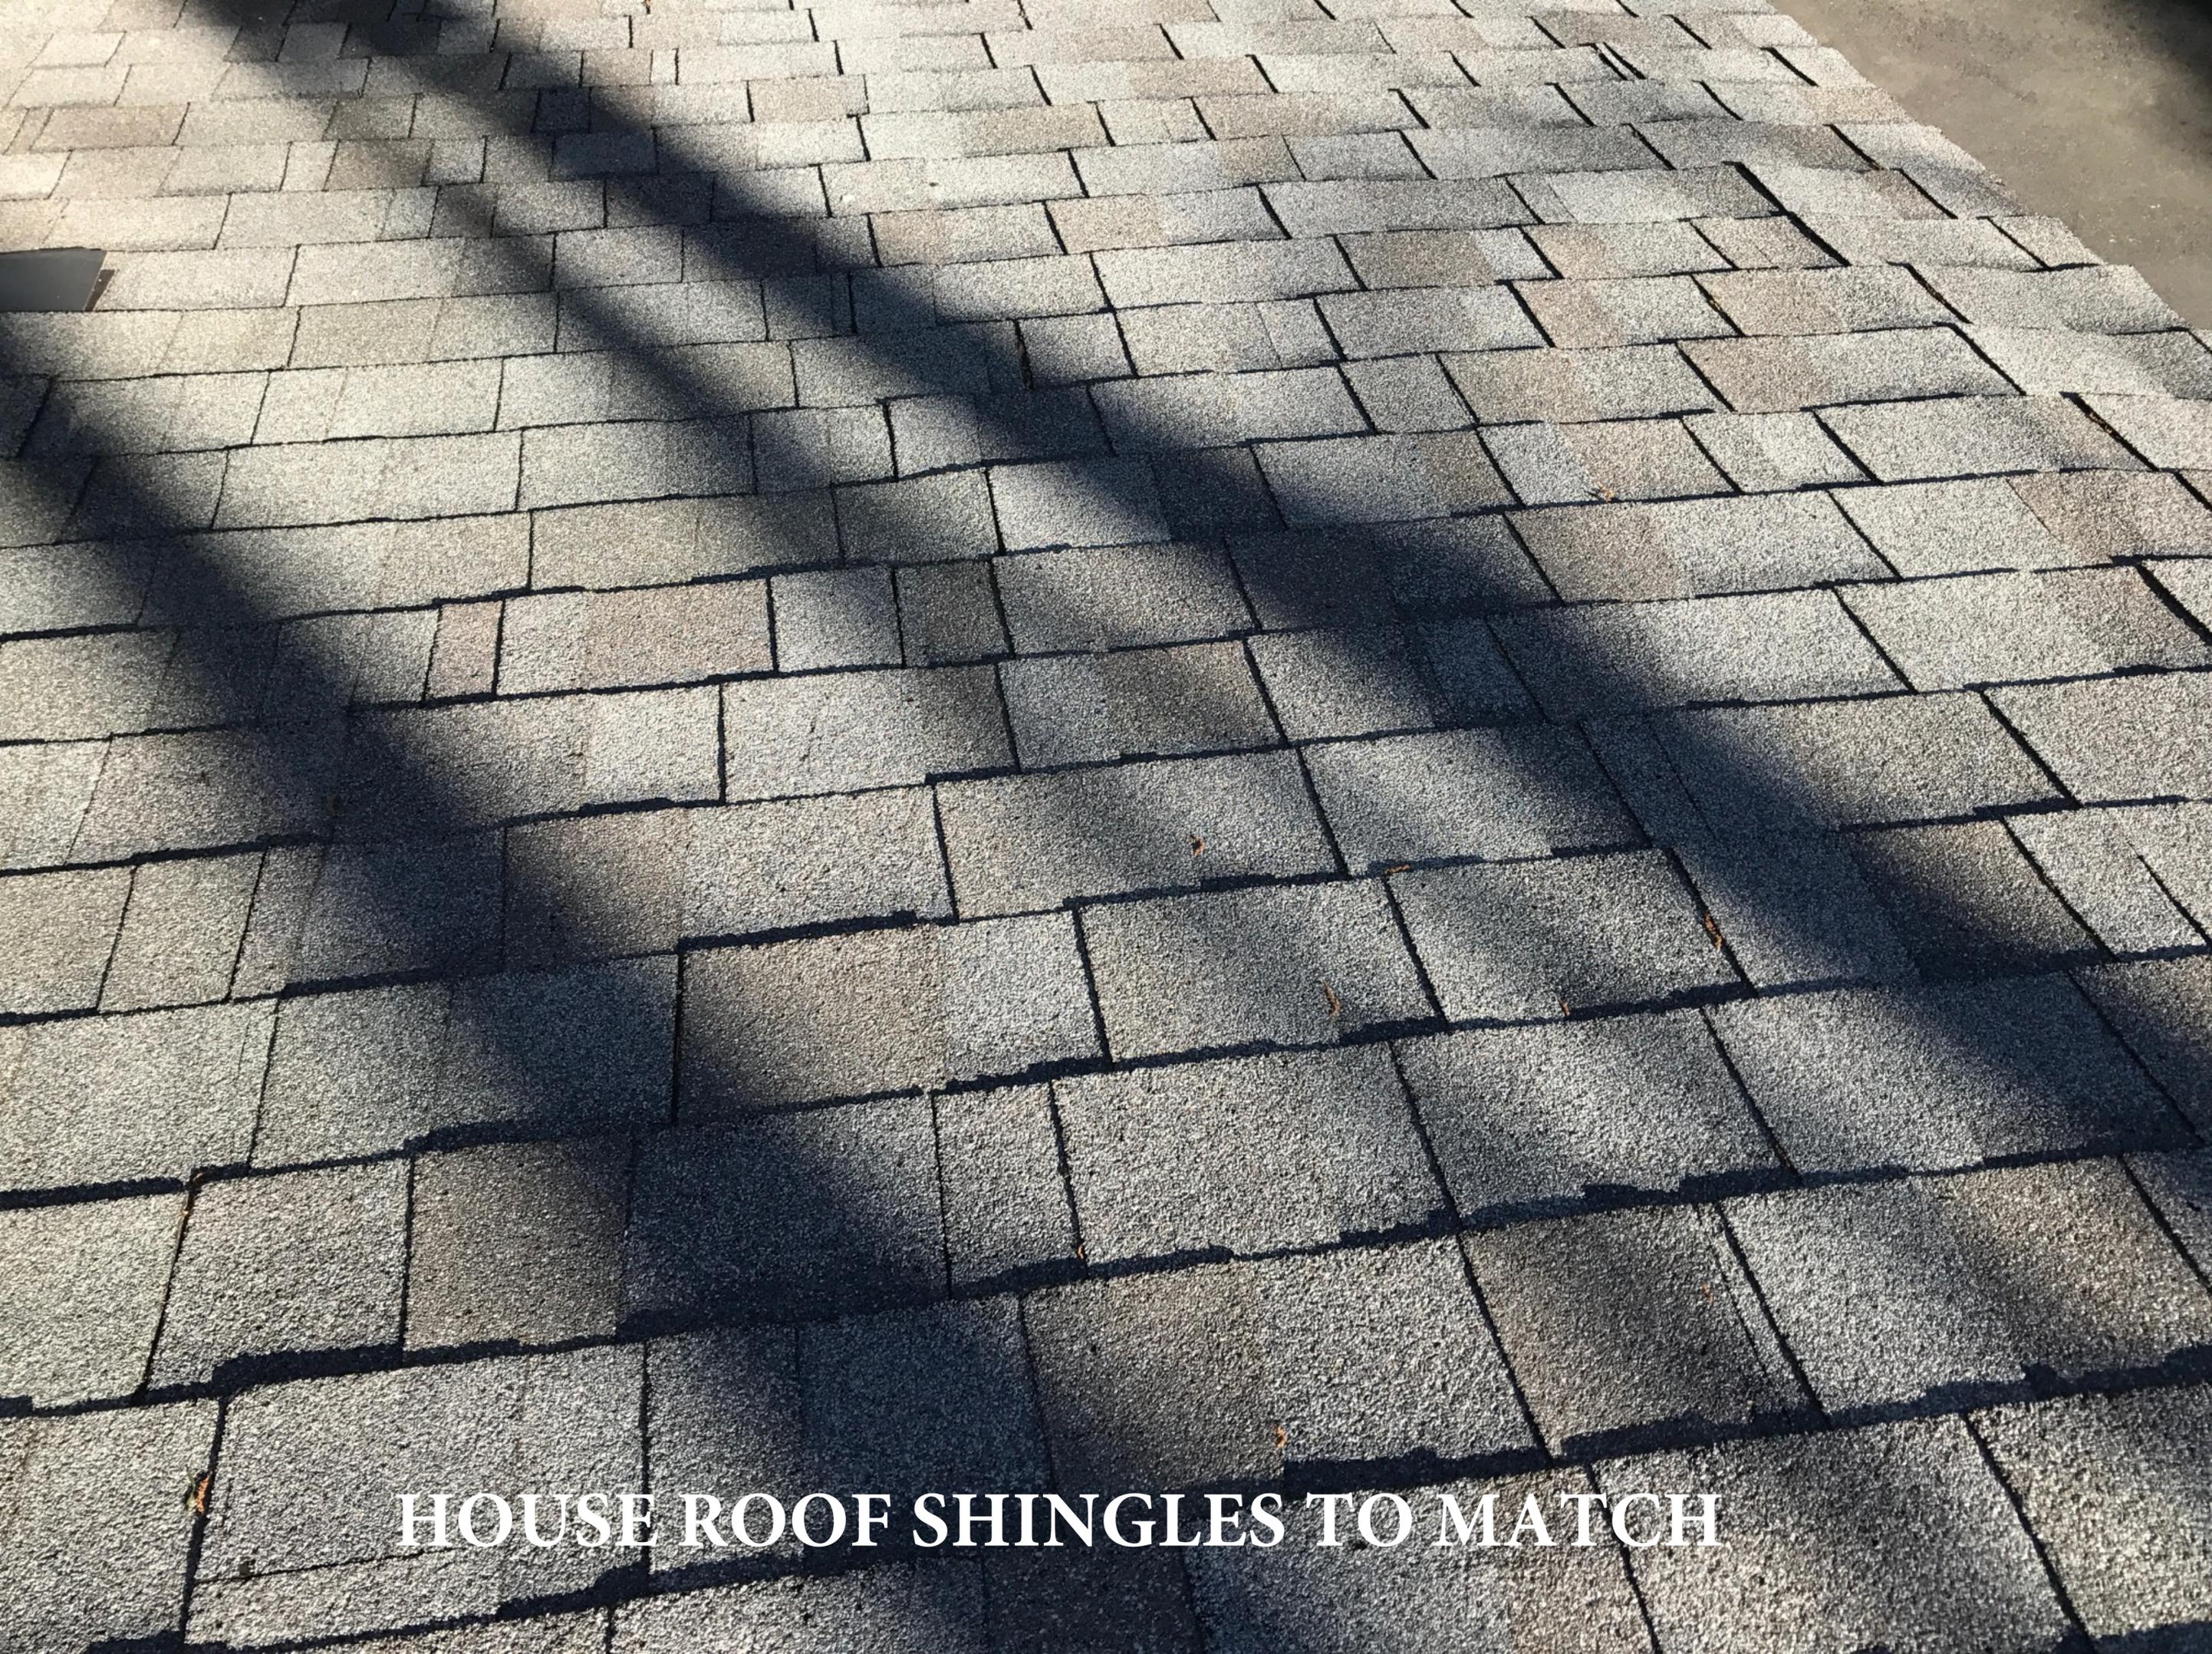
HOUSE ROOF SHINGLES TO MATCH
